# Damage caused to concrete structures along the Tohoku Shinkansen line by the Great East Japan Earthquake and methods used to restore the damage

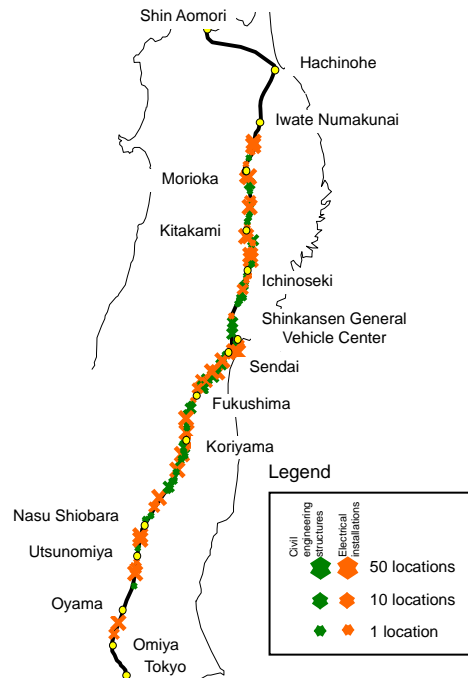
The Great East Japan Earthquake that struck on March 11th 2011 resulted in widespread earth movements lasting for a long time. A great deal of damage was caused to railway structures under the jurisdiction of East Japan Railway Company (JR East), including many along the Tohoku Shinkansen line. Figure 1 shows the locations of major damage to the Tohoku Shinkansen line and the number of damage locations.

Fig. 1 Concrete structures along the Tohoku Shinkansen line damaged by the March 11th Earthquake

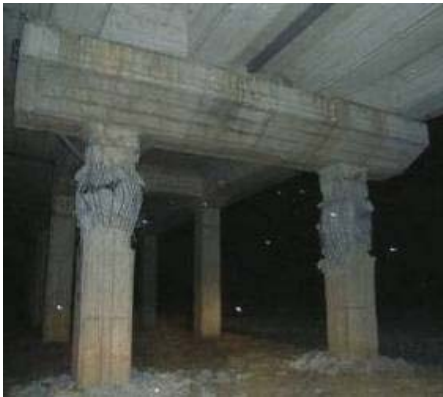
Photo 1 shows a case where the top of a column suffered flexural damage and, as a result, the track dropped slightly. The viaduct in question is a single-layer three-span RC rigid-frame viaduct and the damaged column is located at one end of a block of columns. This block of the damaged viaduct has simple RC girders at both ends, and the damaged column was about 0.4 m shorter than the columns in the middle of the block. There were about nine columns along the Tohoku Shinkansen line that suffered damage like this, causing the track to drop. Of these, columns where concrete had been pushed out from inside were among those damaged by the main March 11th shock. This is probably because of the long duration of the earthquake motions.

Photo 1 Damaged columns of rigid-frame viaduct

The structural performance of the columns whose cross-sectional area had been reduced by the earthquake damage was restored to that prior to the earthquake as follows. First, the girder was temporarily supported with a steel structure, the rebars were cut in the longitudinal direction, and the supports were then jacked up to the correct level. The rebars were then made good using welded joints. Resin was injected into cracks and larger gaps were filled with mortar (See Photo 2). This restoration work took about seven days for each column. Permanent restoration work, involving seismic reinforcement of all the columns in each damaged block with a steel casing to increase seismic capacity, will take place in future.

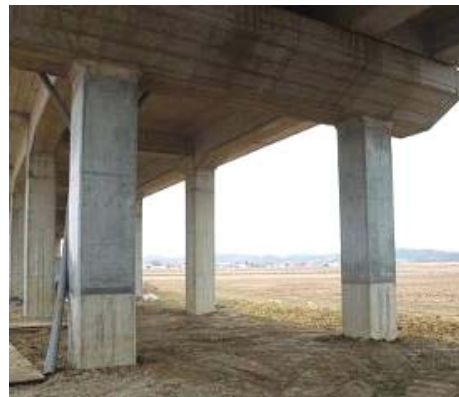
Photo 2 Restored columns

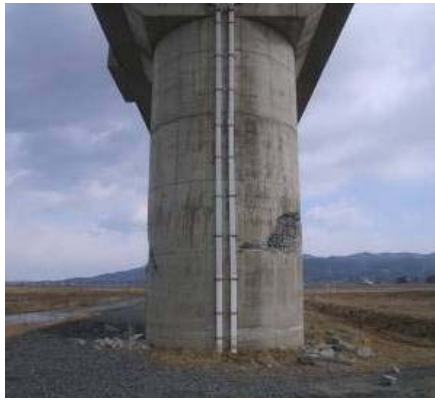
Photo 3 shows a bridge pier damaged by the March 11th main shock. The pier is a cylindrical reinforced concrete single-column bridge pier 4.5 m in diameter and 18.0 m

high. The pier supports two PC box girders with spans of 50 m and 35 m. Damage consisted of spalling of the cover concrete and cracking at an anchor point part way up the longitudinal rebars. Photo 4 shows the restored column. The reduced cross-sectional area of the damaged column was restored by injecting resin into cracks, rearranging the transverse rebars, and placing non-shrinking mortar. The work of restoring the damaged pier took about 8 days.

Photo 3 Damaged column

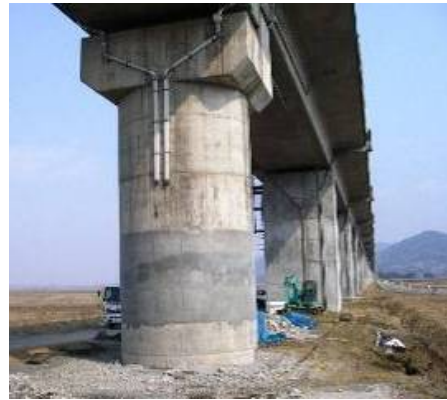
Photo 4 Restored column

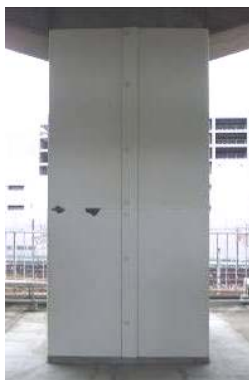
As already mentioned, a program of seismic reinforcement of rigid-frame viaducts and single-column bridge piers with low seismic capacity was ongoing. Reinforcement of structures with extremely low seismic capacity had already been completed. Generally, the seismic reinforcement method used for RC rigid-frame viaducts was to place a steel casing around the column. In cases where the below-girder space was in use for some purpose, newly developed methods were adopted. Photos 5 to 8 show the columns of viaducts seismically reinforced by these various methods. Although there was minor damage to these seismically reinforced viaducts in the earthquake, such as peeling of paint from joints between sections of steel reinforcement casing, no serious damage occurred. The earthquake thus unintentionally ascertained the efficacy of these seismic reinforcement methods.

Photo 5 Seismic reinforcement using steel casing sections (interlocking joints)

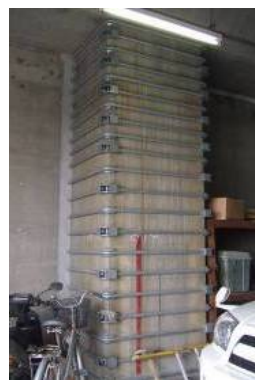
Photo 6 RB seismic reinforcement

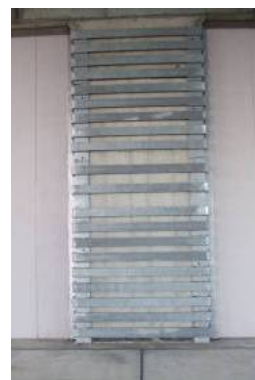
Photo 7 RP seismic reinforcement

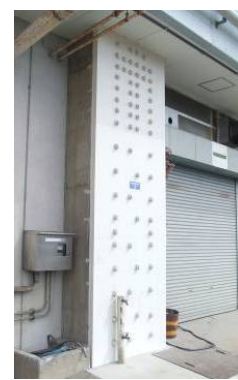
Photo 8 Single-face seismic reinforcement
