April 7, 2011

JSCE Concrete Committee
Subcommittee for Survey of Great East Japan Earthquake
Damage and Countermeasures
Survey Team on Damage to Concrete Structures in
Fukushima Prefecture

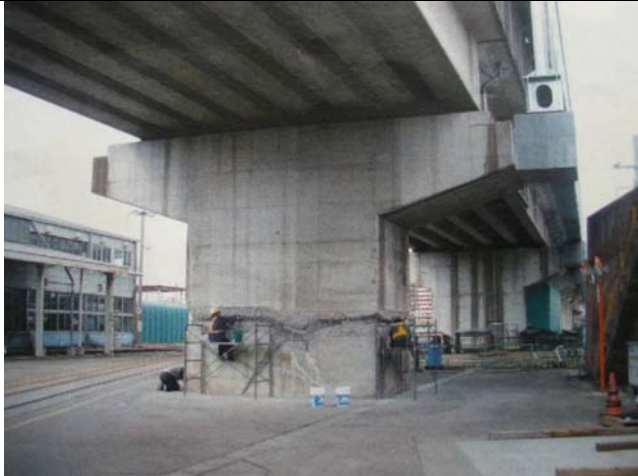
The structure surveyed was a girder type viaduct on the Tohoku Shinkansen line. The damaged pier supports two PC girders, one with a 40 m span and the other with a 30 m span. Concrete in a region about 50 cm in width had broken away, mainly near the rebar cut-off plane where the cross-sectional area of the pier changes. Emergency repair work had already been completed at the time of the survey. This consisted of arranging tie hoops in the damaged portion and pouring in non-shrinkage mortar. Similar damage was observed to a second bridge pier (P13) some distance away.

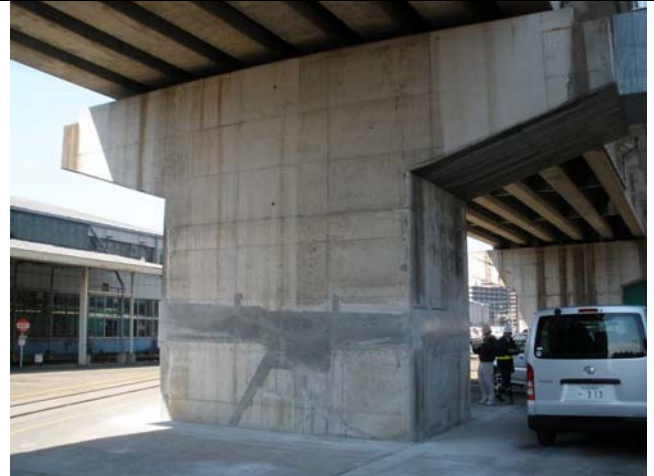
Damage near the rebar cut-off plane where the cross-sectional area changes
(Under repair, Source: East Japan Railway Company)

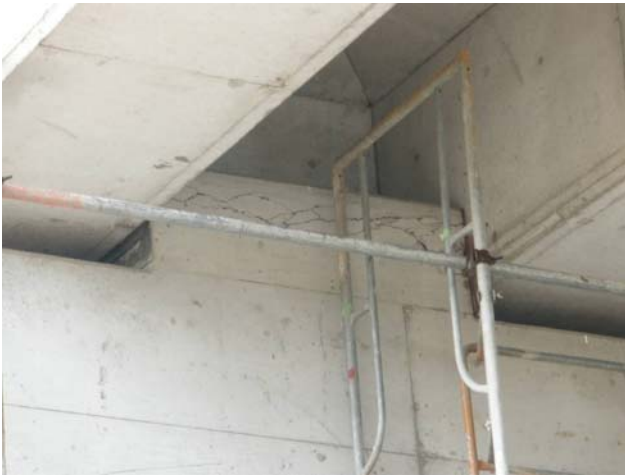
Koya Viaduct
Damage to RC stopper designed to prevent falling of the girder

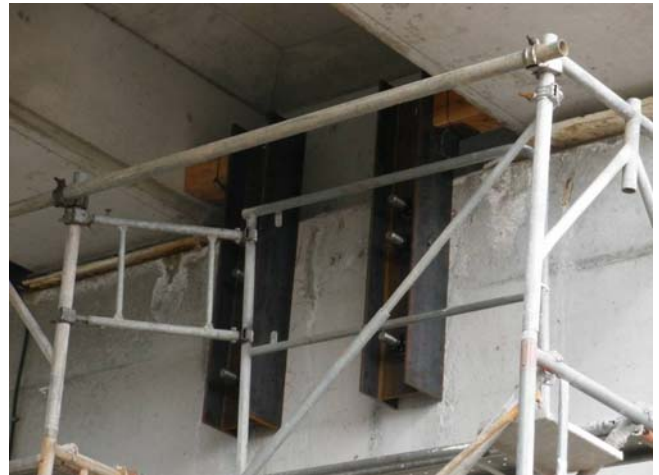
Koya Viaduct
Repairs to steel restrictor shoe

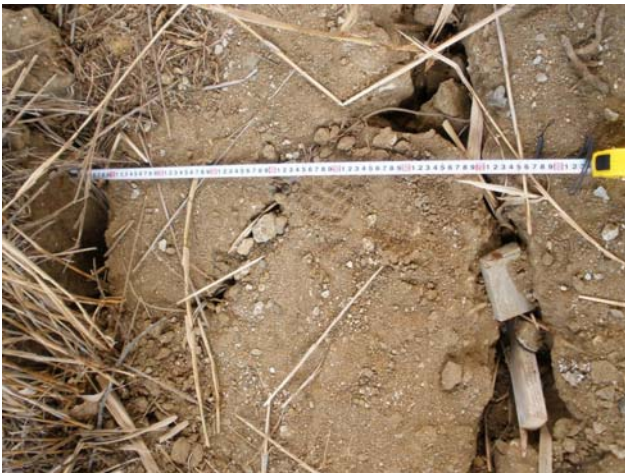
Koya Viaduct
Cracks in ground at base of viaduct pier

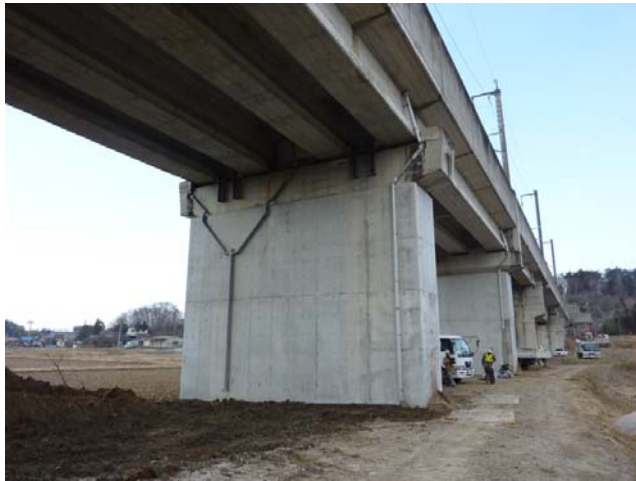
Matsuzuka Viaduct
Damaged girder support

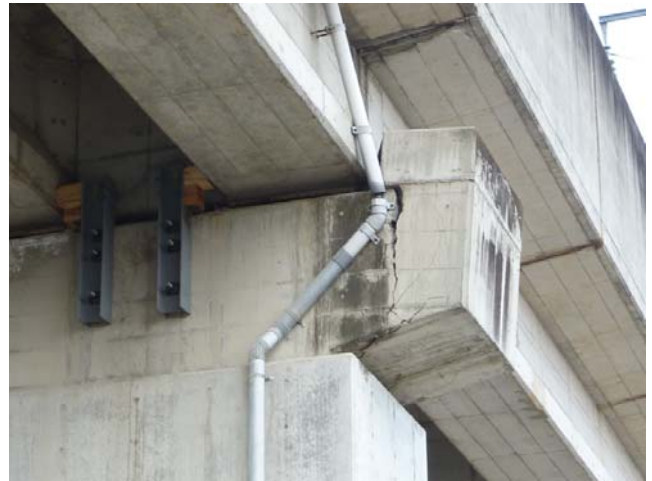
Matsuzuka Viaduct
Damaged girder support (close-up)

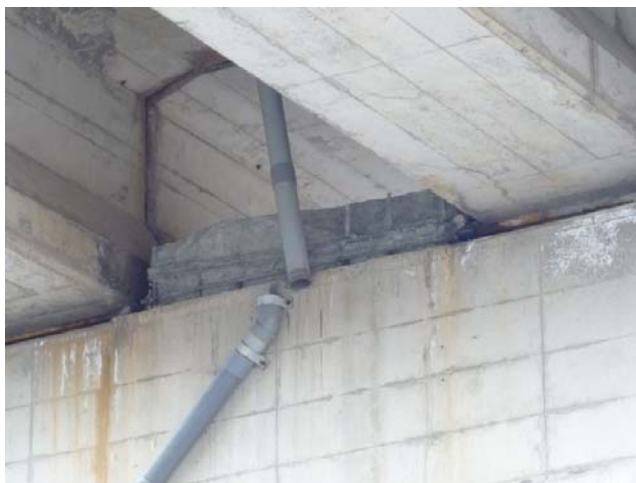
Matsuzuka Viaduct
Damaged RC stopper designed to prevent falling of the girder

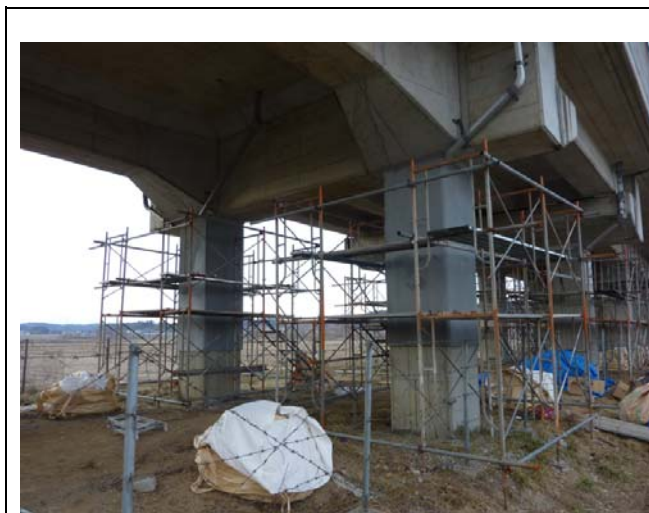
No. 2 Shijiyudan Viaduct
Damaged columns being repaired by restoration of their full cross-sectional area

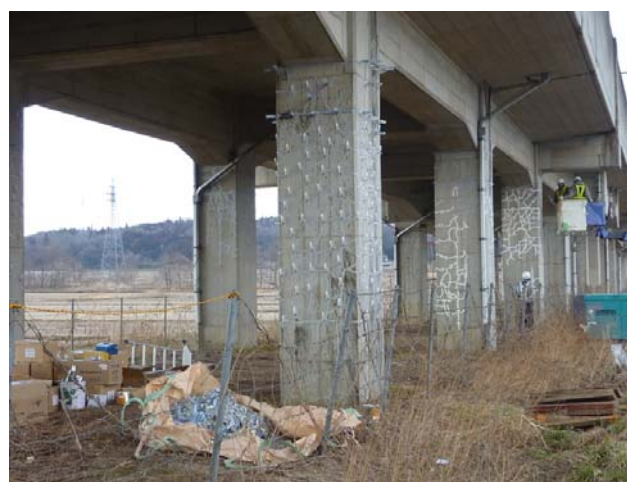
No. 2 Shijiyudan Viaduct
Damaged columns being repaired by grouting the cracks with resin

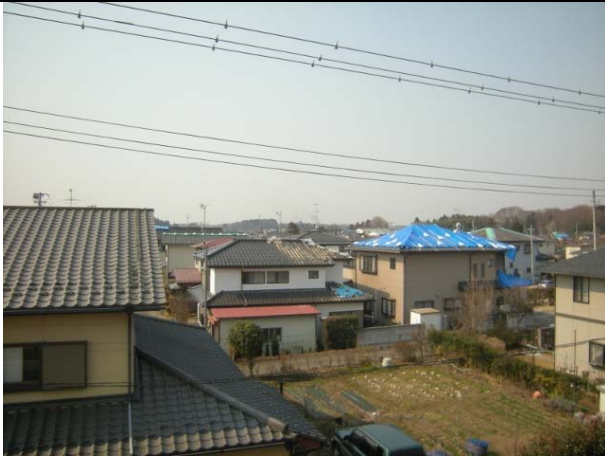
<p style="text-align: center;">Kasaishi Viaduct P2 onward</p> <p>There was no noticeable damage to major structural members.</p>	<p style="text-align: center;">Conditions around Kasaishi Viaduct (Photo taken from on the viaduct)</p> <p>Damaged roof tiles of private residences (more prominent than in other survey sites)</p>

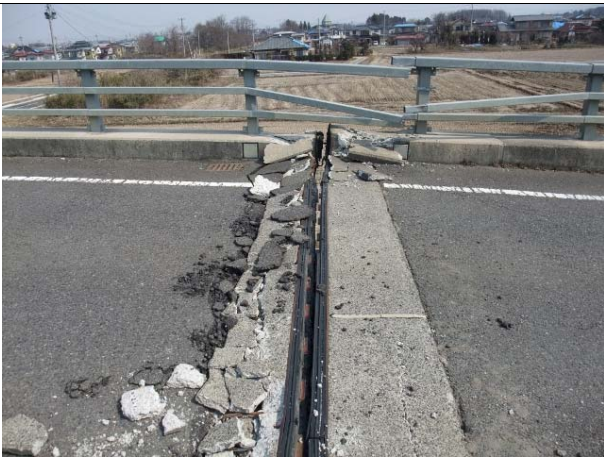
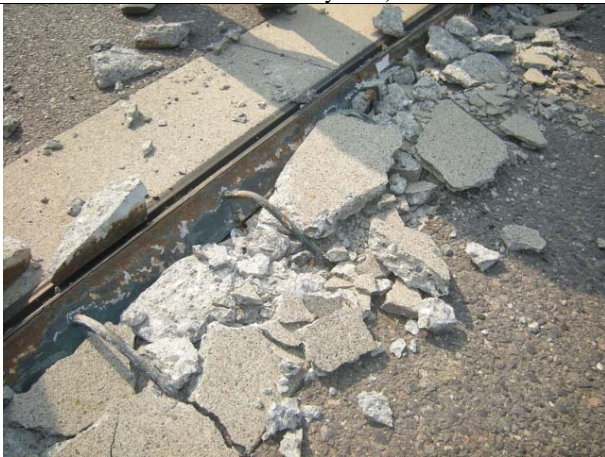
<p style="text-align: center;">Kasaishi Viaduct Above A1</p> <p>Damaged parapet (left), expansion joint, curb, and bridge railing</p>	<p style="text-align: center;">Kasaishi Viaduct Above P4</p> <p>Damaged expansion joint (steel bars forced upward by compressive force generated during girder collision)</p>

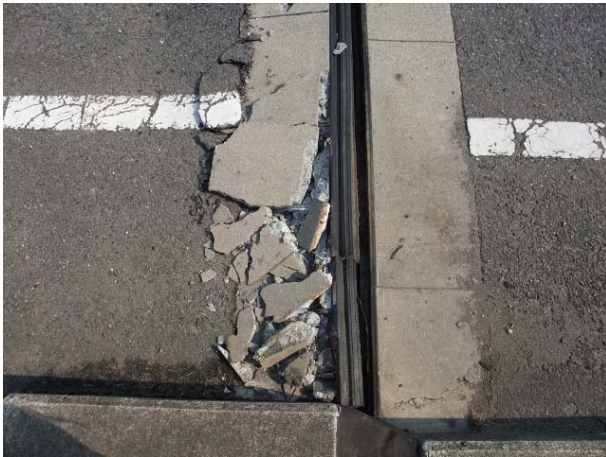
Kasaishi Viaduct
Above P4
Horizontal residual displacement of girders (about 5 cm) and
damaged expansion joint

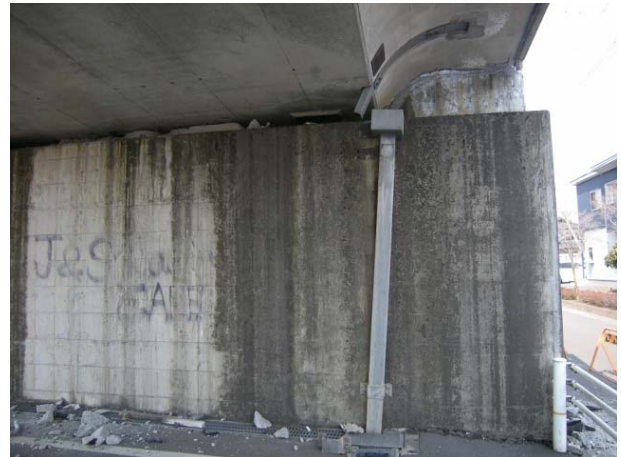
Kasaishi Viaduct
A2
Damaged displacement control mechanism (anchor bar damage
and fallen concrete base

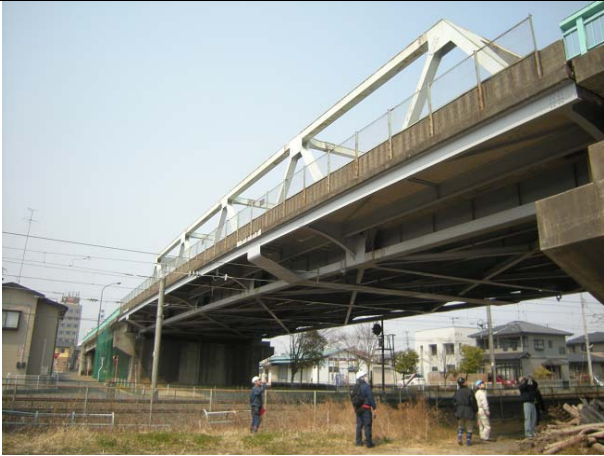
Daikoku Bridge
General view

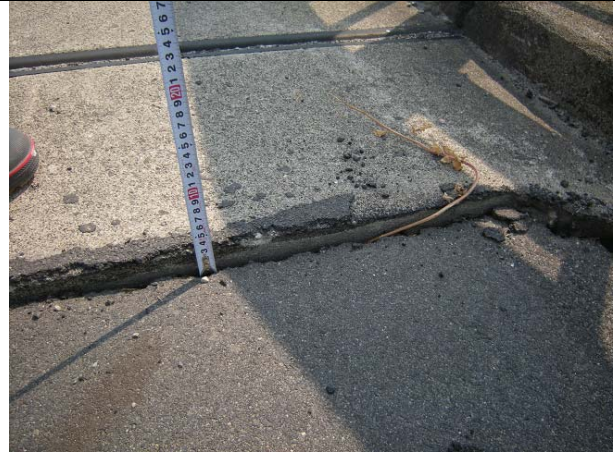
Combines post-tensioned PC girder spans at both ends with a simple truss girder bridge in the center. Abutment A1 visible at far end in the photo

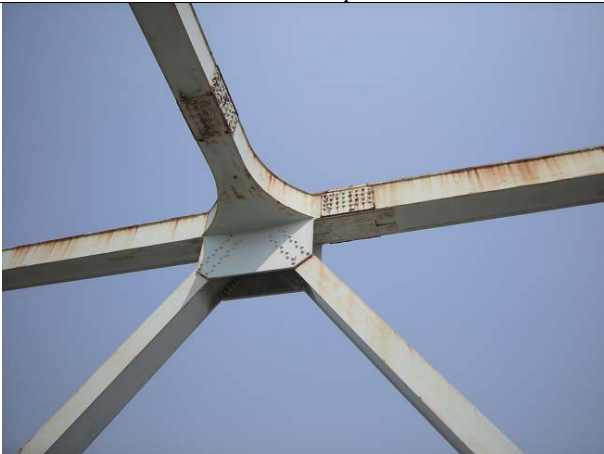
Daikokubashi Bridge
G1

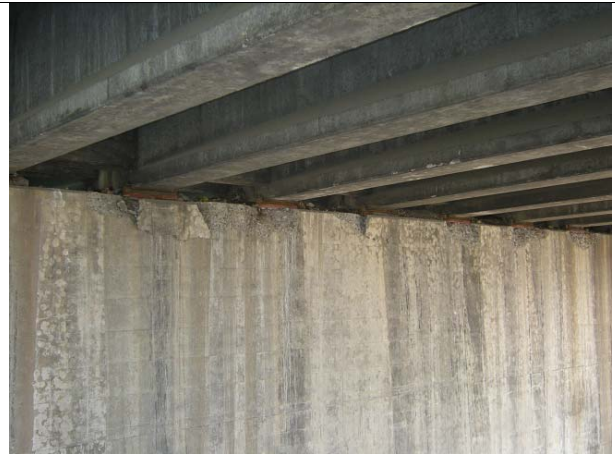
Daikokubashi Bridge
P4 girder support

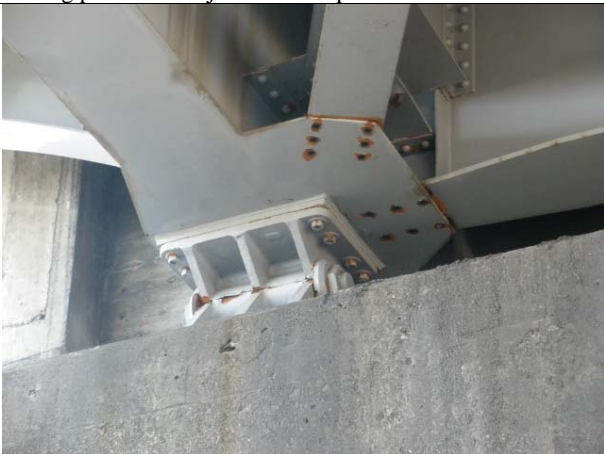
Daikokubashi Bridge
Joint between P2 and G2
Severed rivets

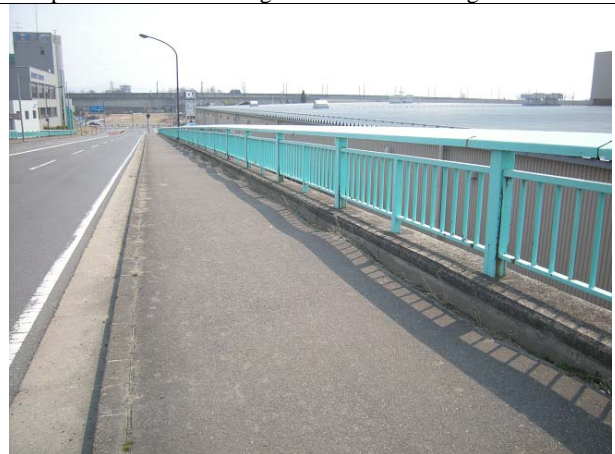
Daikokubashi Bridge
Sidewalk

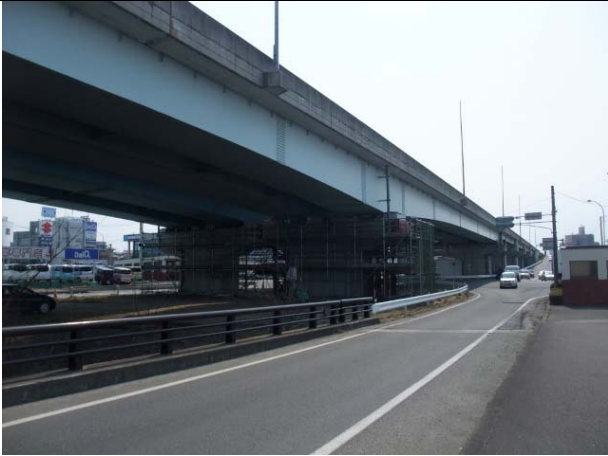
Kamedaohashi Bridge
General view
(Center left: P5 on up side; center right: P5 on down side)

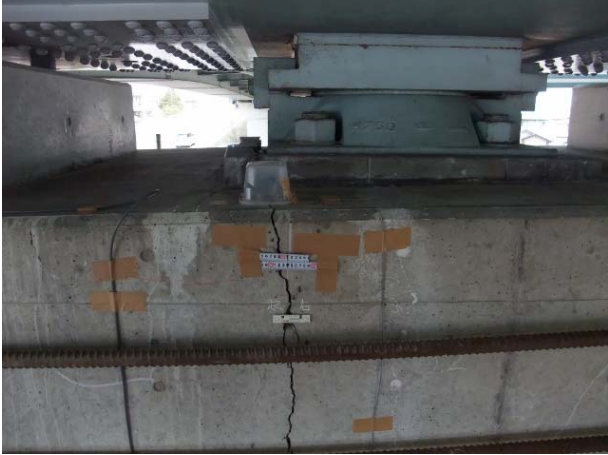
Kamedaohashi Bridge
P5 on down side (steel bearing)
Vertical cracks developed from the end of the steel bearing
(maximum width: 11 mm)

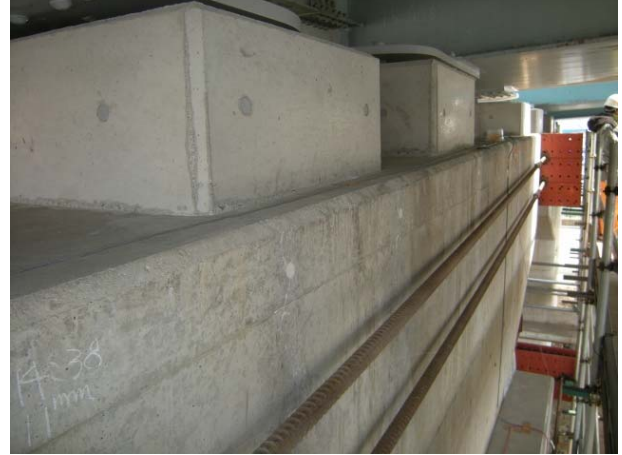
Kamedaohashi Bridge
P5 on down side (stopper)
Undamaged stopper

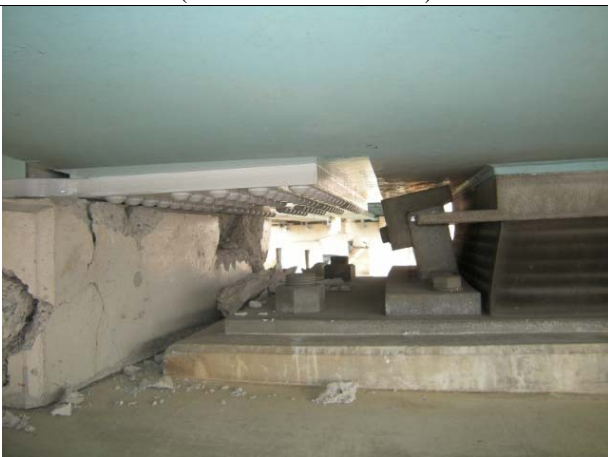
Kamedaohashi Bridge
P5 on up side (rubber bearing and RC stopper)
Deformed rubber bearing and damaged RC stopper

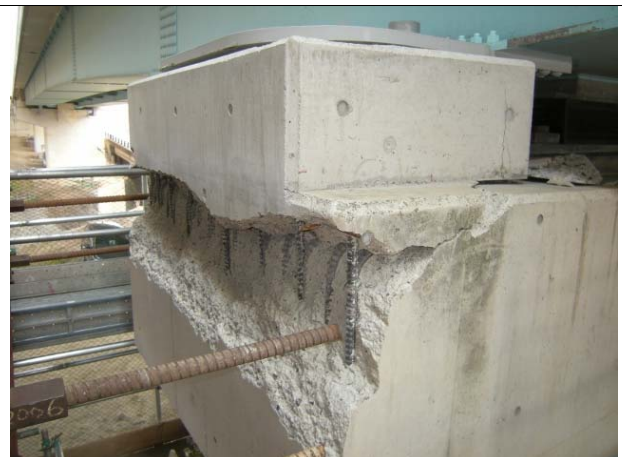
Kamedaohashi Bridge
P5 on up side (RC stopper)
Damage around stopper block

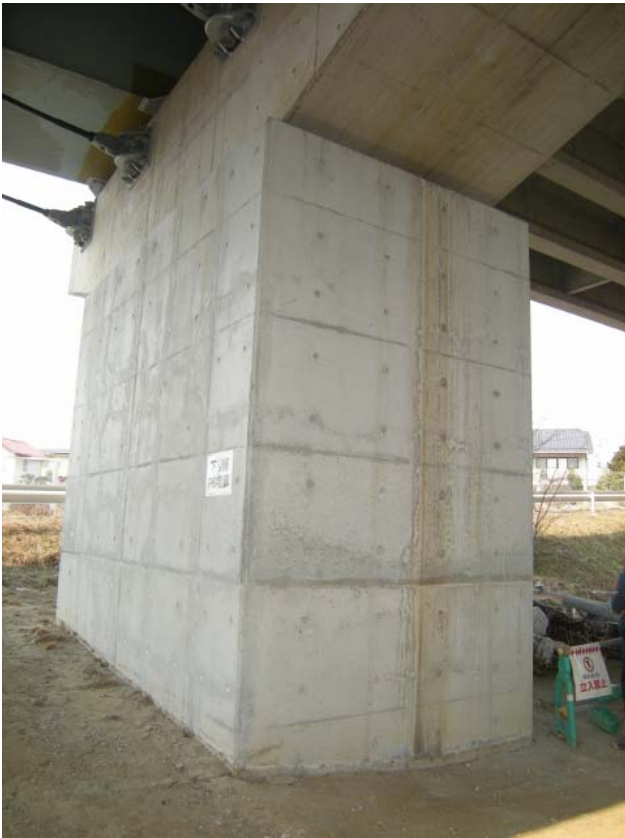
Kamedaohashi Bridge
P6
No noticeable damage

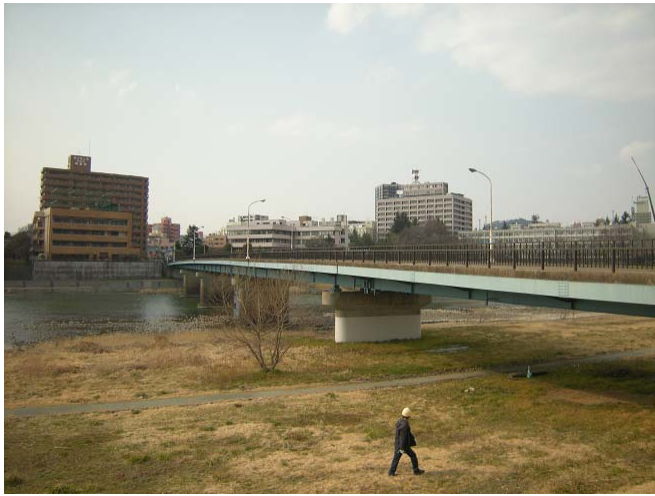
Tenjin Bbridge
General view

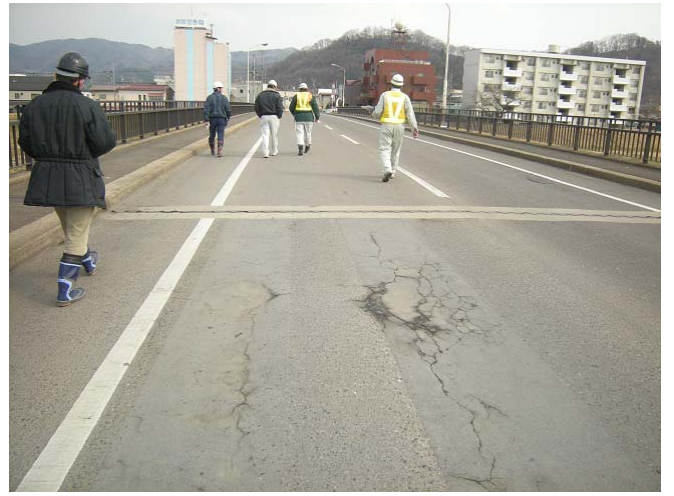
Tenjin Bbridge
Bridge deck surface
Cracks were observed

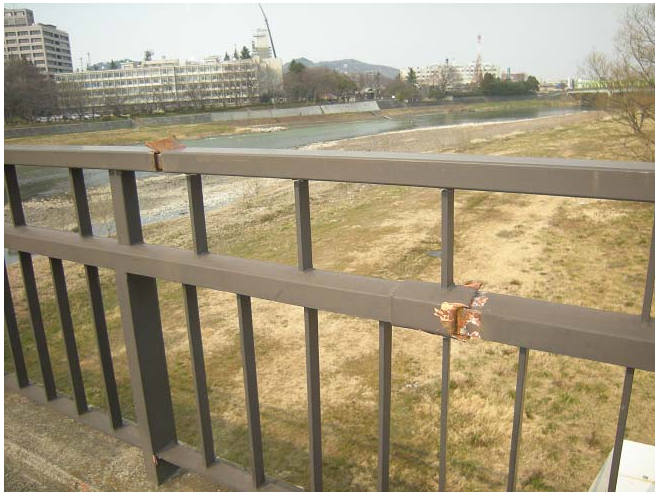
Tenjin Bridge
Bridge railings

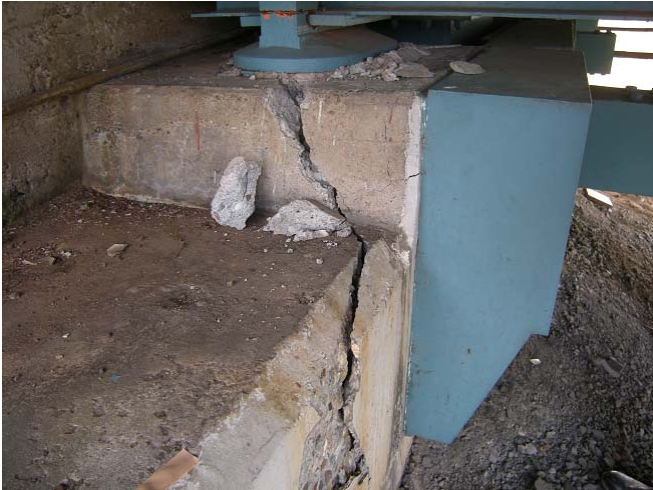
Tenjin Bridge
A2 shoe

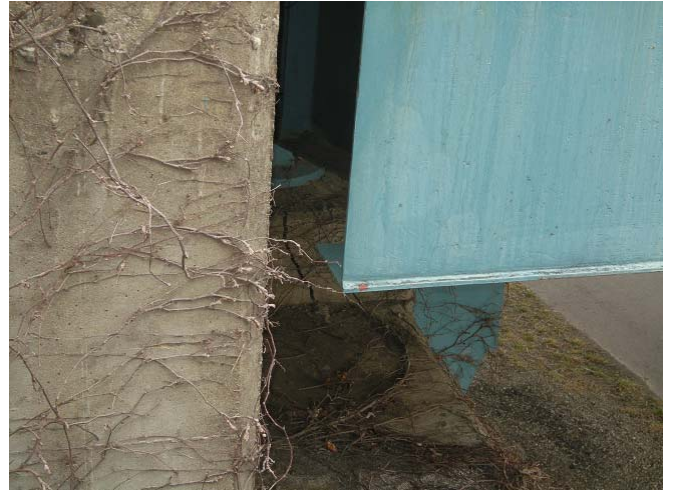
Tenjin Bridge
A1 shoe
