# Report on damage to concrete structures in Iwate Prefecture

March 30, 2011 (First Report)

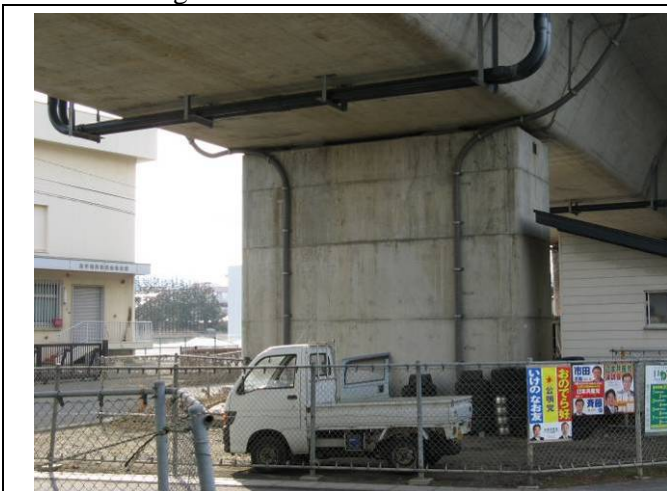
No. 2 Nishi Senboku BV  
Undamaged

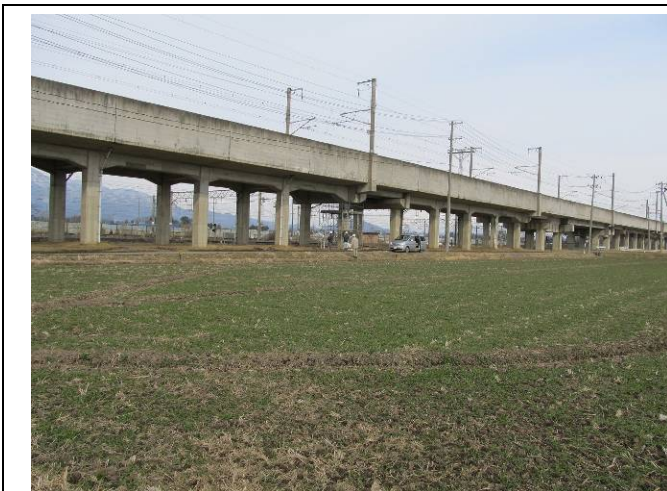
No. 1 Akabayashi BL  
R3 and subsequent rigid frames: undamaged

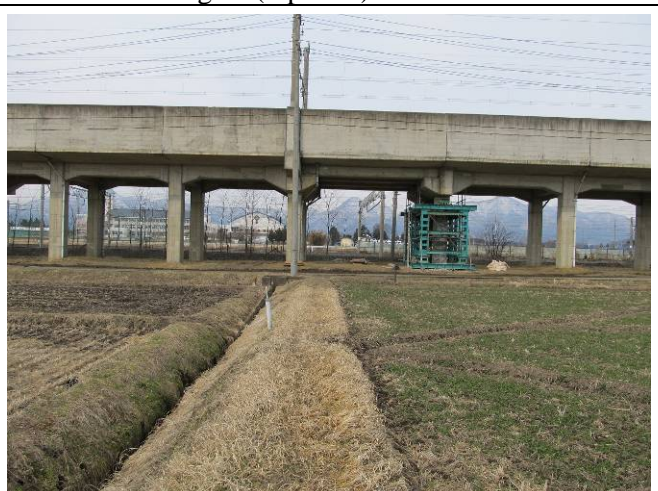
No. 1 Akabayashi BL  
R1: undamaged  
R2 (left column): damaged (and repaired)

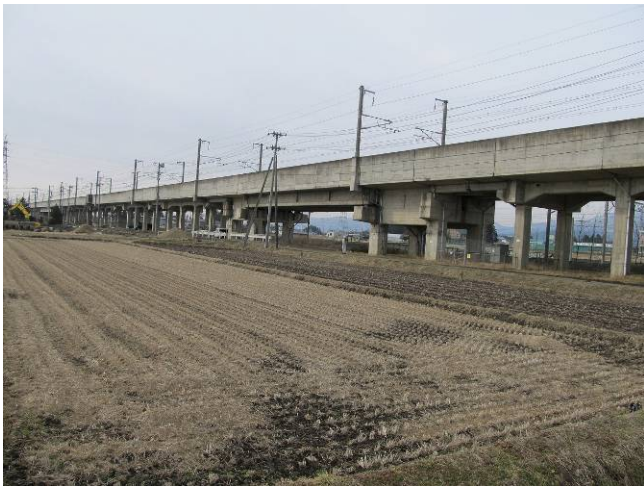
No. 1 Akabayashi BL  
R1 and preceding rigid frames: undamaged

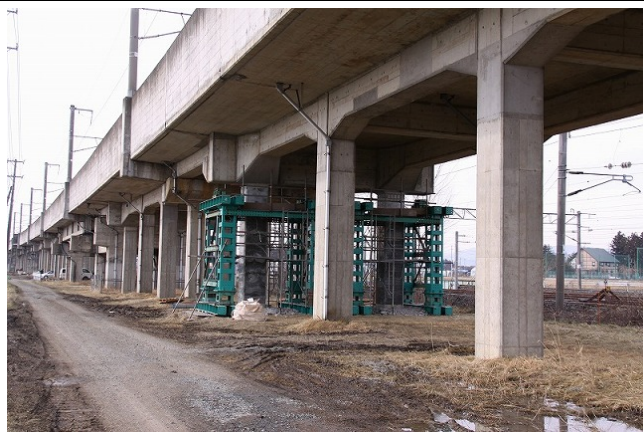
No. 1 Akabayashi BL  
R2 (columns at both ends): damaged (and repaired)  
(The nearer rigid frame in the photo is R2.)  
Emergency repair work was being carried out on the two columns at the Tokyo end and one column at the Morioka end. No noticeable damage was observed on intermediate columns, although flexural cracking was seen.

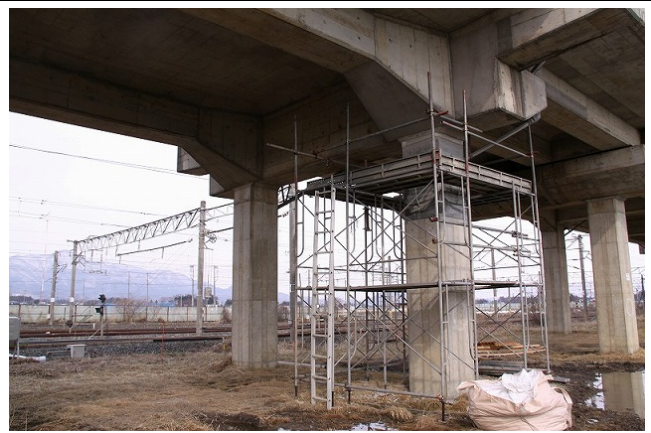
No. 1 Akabayashi BL  
R2 north end columns: damaged (and repaired)  
Of the R2 bridge pier columns at the north, only the right column (on the near side of this photo) was being repaired. R3 on the far side in this photo was undamaged.

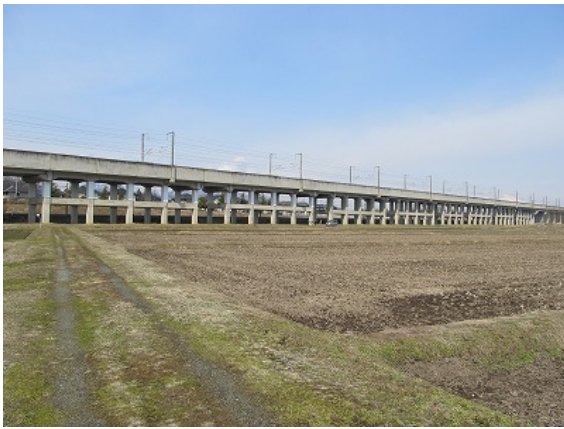
Yahaba Minami BL  
R4 to R11

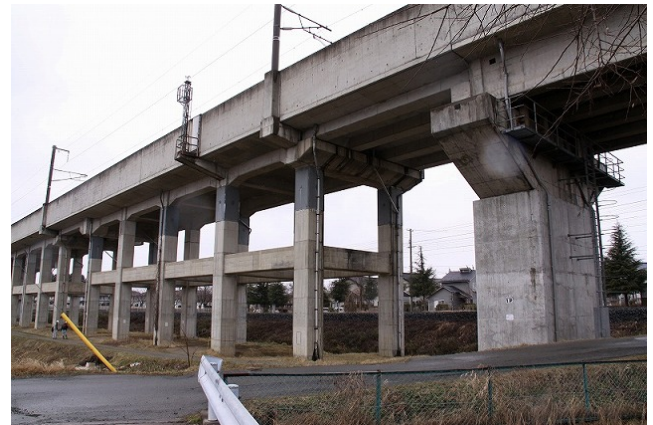
Yahaba Minami BL  
From the right: Ainono BV P1, R11 to R10  
No noticeable damage was found in columns, although shear cracking had occurred in the 1<sup>st</sup> story transverse beams.

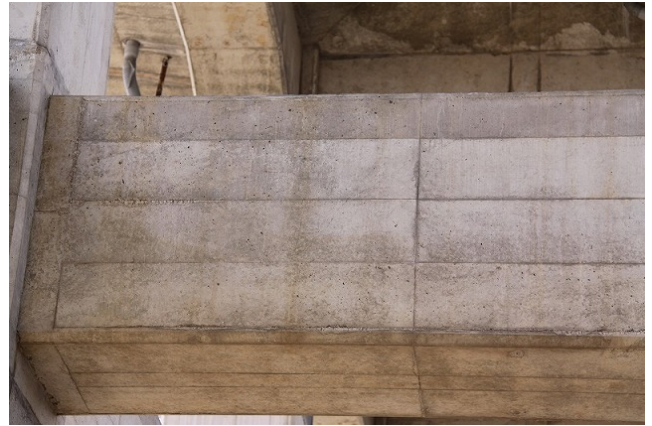
The 1<sup>st</sup>-story transverse beams: fine cracks were found.

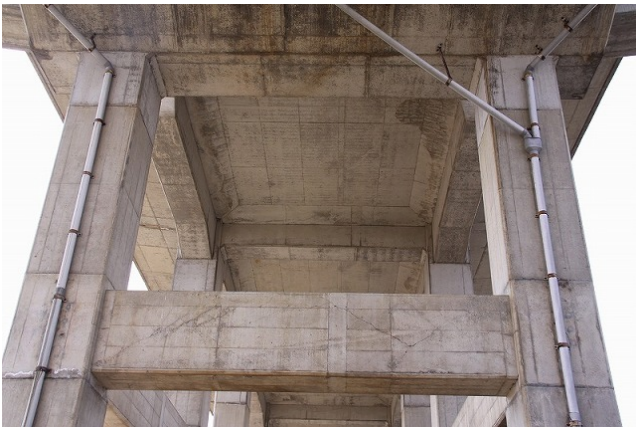
The 1<sup>st</sup>-story transverse beams: fine cracks were found.

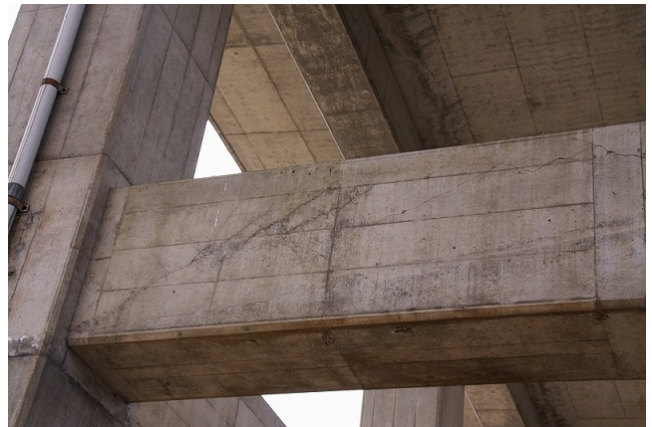
The 1<sup>st</sup>-story transverse beams: cracks were found.

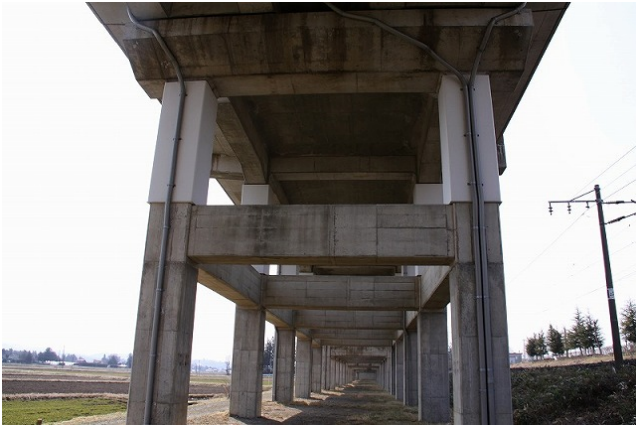
Yahaba Minami BL  
 R1 to R5 (2-story rigid frame; the 2-story columns had undergone seismic retrofitting with steel jacketing)  
 The 1<sup>st</sup>-story transverse beams: fine cracks were found.

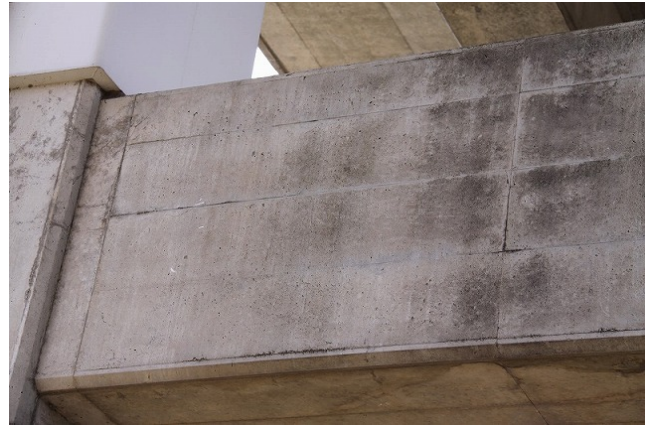
Yahaba Minami BL  
 R1 to R5 (closeup of the 1<sup>st</sup>-story beam end in photo to the left)  
 The 1<sup>st</sup>-story transverse beams: fine cracks were found.

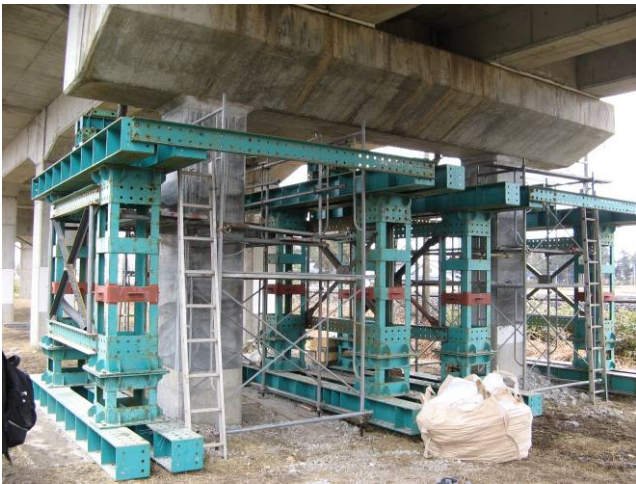
No. 3 Tokuta BL  
 R1 columns at the South end: damaged (and repaired)

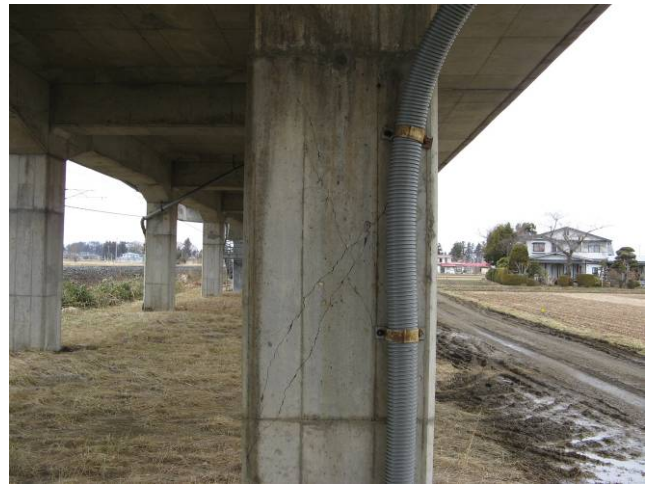
No. 3 Tokuta BL  
 R1 intermediate column: cracks were observed (not yet repaired)  
 X-shaped diagonal cracks were found on the column surface facing the longitudinal direction

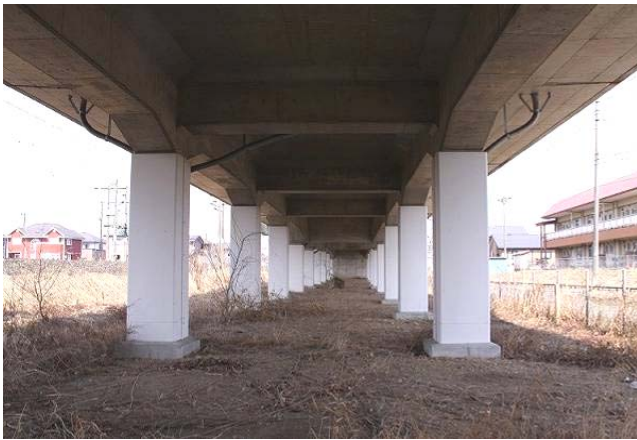
No. 3 Hizume BL  
R1 and R2: Undamaged  
Columns had already undergone seismic retrofitting with steel jacketing.

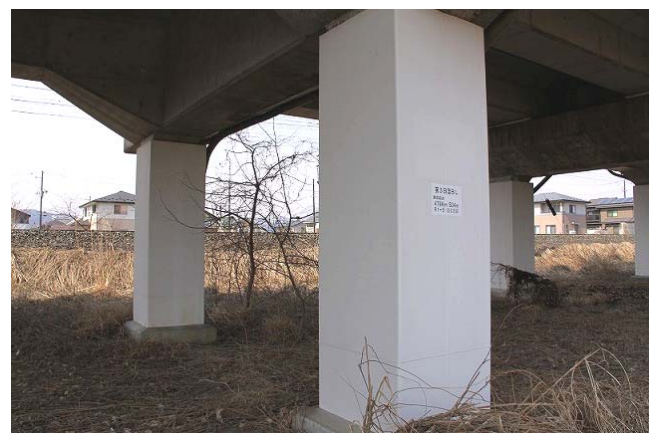
No. 3 Hizume BL  
R1 side columns  
Columns had already undergone seismic retrofitting with steel jacketing.

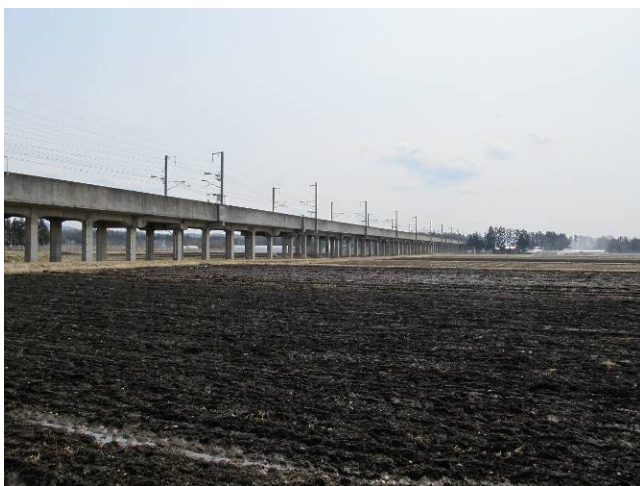
No. 5 Inohana BL  
R1 to R12 (Not yet seismically retrofitted)

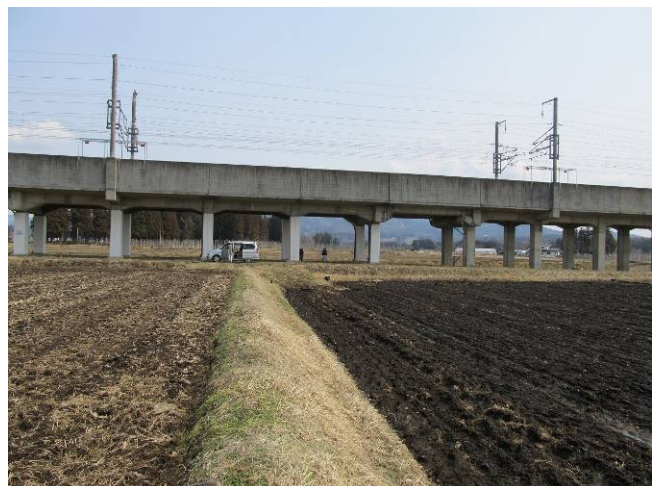
No. 5 Inohana BL  
R13 (Seismically retrofitted after damage)

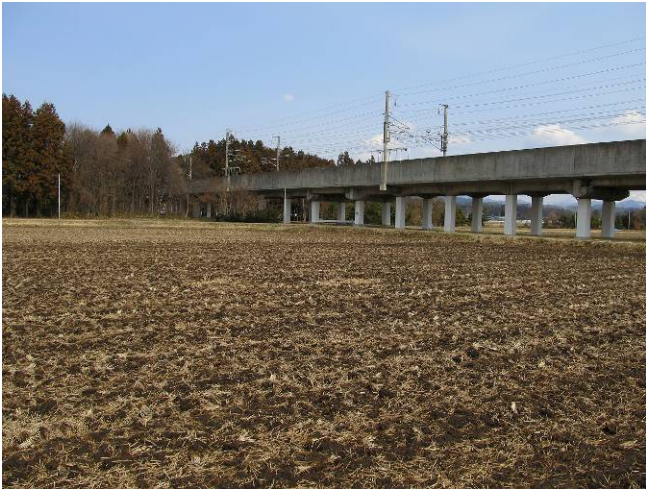
No. 5 Inohana BL  
R14 (Seismically retrofitted after damage)

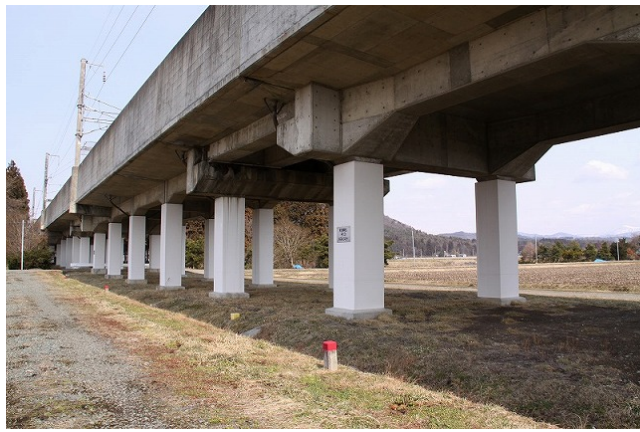
No. 5 Inohana BL  
R13 in foreground and R14 behind: no damage to main structural members  
Columns had already undergone seismic retrofitting with steel jacketing.

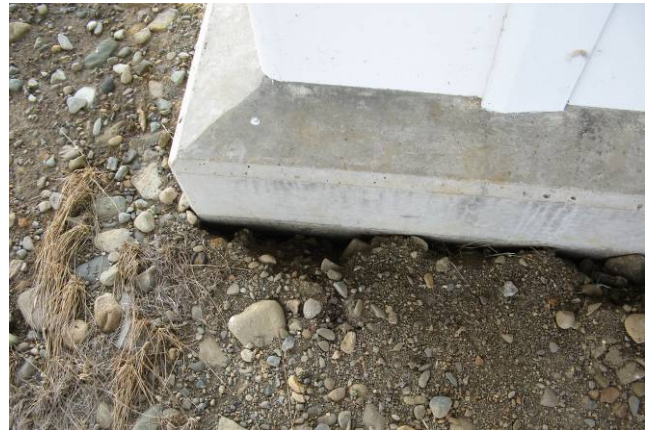
No. 5 Inohana BL  
R13: gap between column base and fill

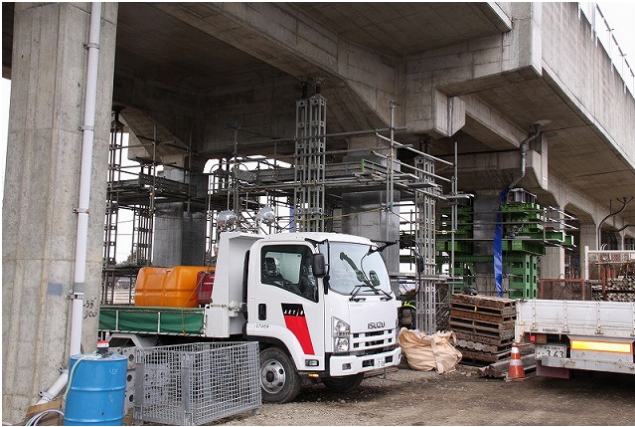
- R1 to R3: four side columns were damaged (and had been repaired).
- R4: concrete cover spalled off from the western side column at the south end; the remaining three sides of the column suffered diagonal cracking.
- R5: four side columns suffered diagonal cracking.
- R6: four side columns were damaged (and had been repaired).
- R7: four side columns were damaged; two intermediate columns at the north end were damaged (and had been repaired).

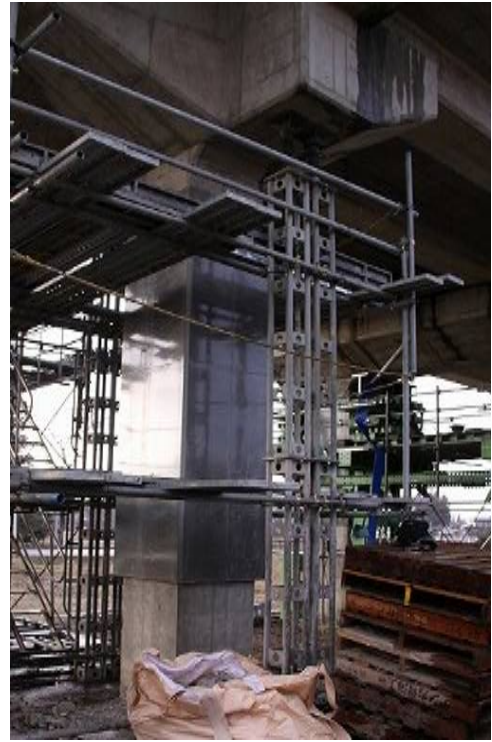
R1 North-end columns and R2 South-end columns: damaged  
(Repaired by jacking up the columns, replacing rebars, and restoring the reduced cross-sectional area.)

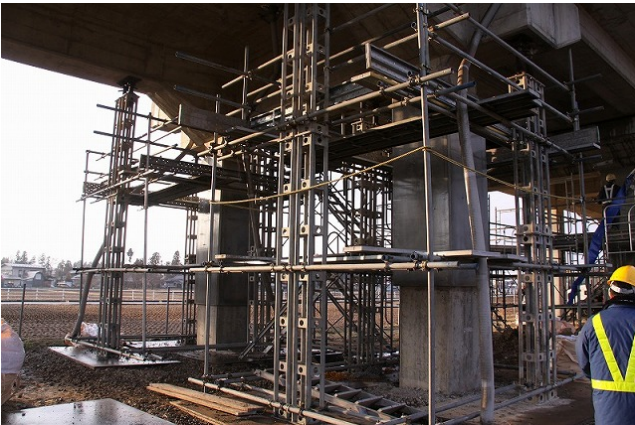
The work of restoring the reduced cross-sectional area by repairing the lost cover concrete was being carried out over a large area of the surface. To restore the rebar arrangement, the cross-sectional area was restored over a large area in the axial direction.

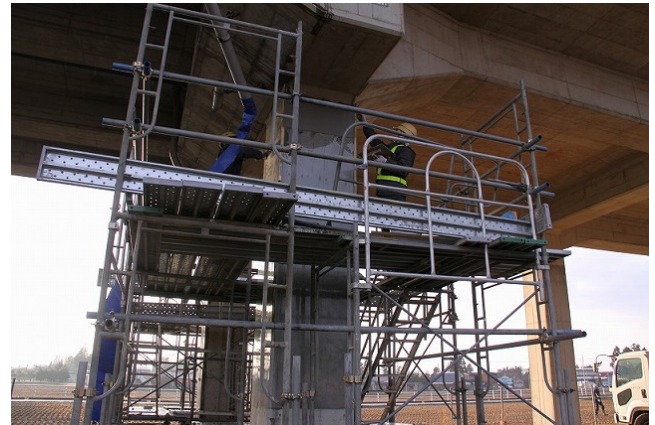
The work of restoring the reduced cross-sectional area by repairing the lost cover concrete was being carried out over a large surface area. To restore the rebar arrangement, the cross-sectional area was restored over a large surface area in the axial direction.

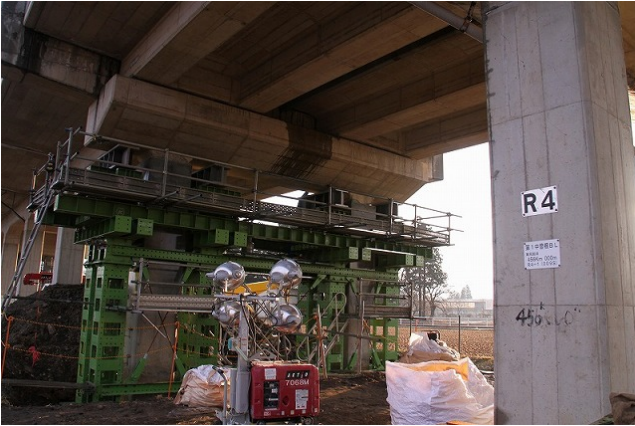
No. 1 Nakasone BL  
 R3 North-end columns: damaged (and repaired)  
 R4 end-column at South-end: diagonal cracking was observed.

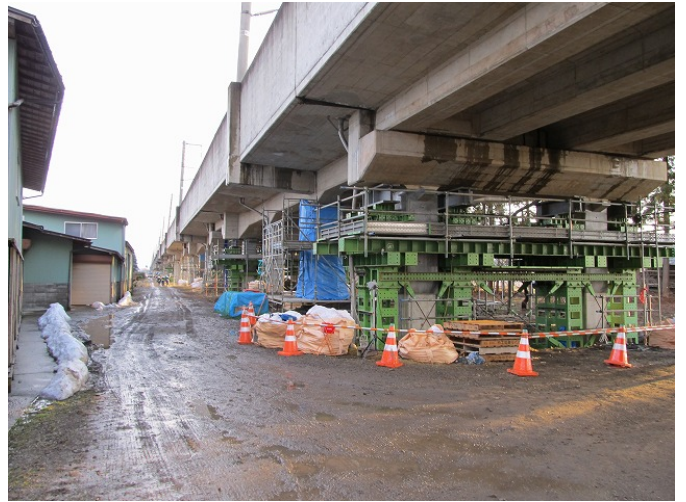
No. 1 Nakasone BL  
 R7 North-end columns: damaged (and repaired)

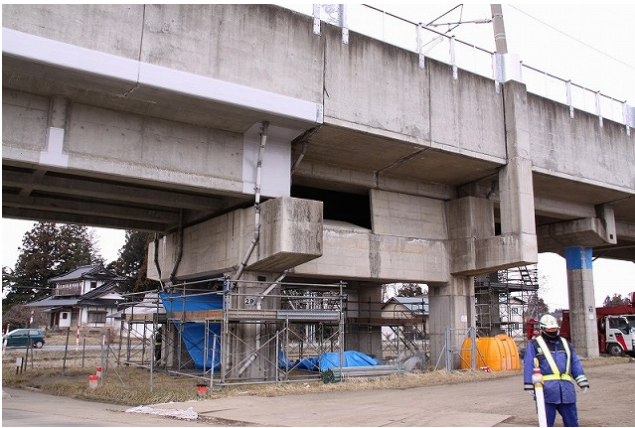
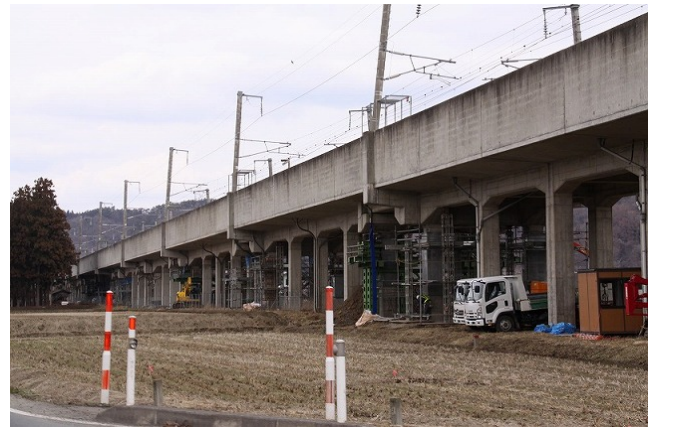
Tilted catenary poles

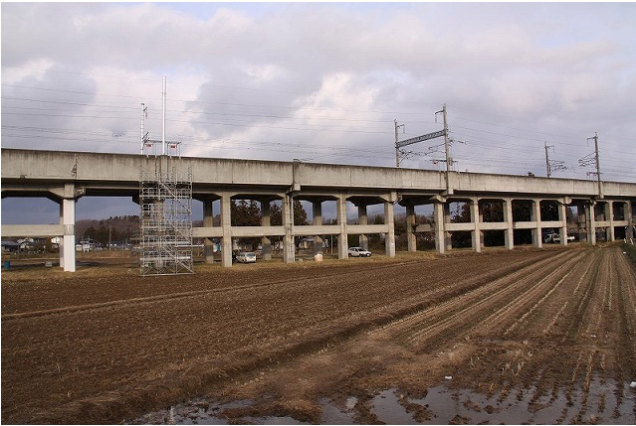
- R4 (Seismically retrofitted): undamaged
- R1 to R3 (Not yet seismically retrofitted): 1<sup>st</sup>-story beams and end-joints damaged (and repaired partly by grouting)

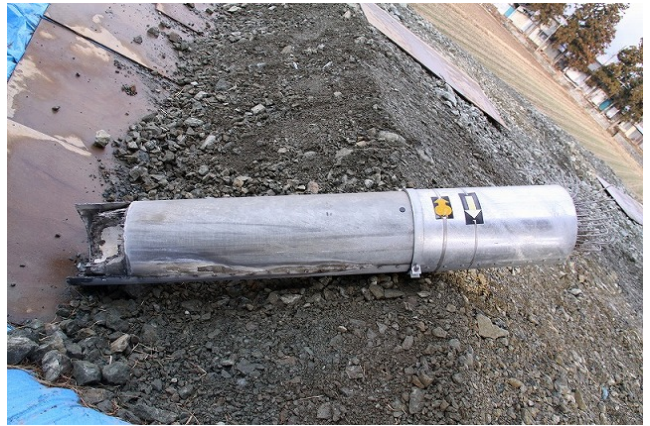
Broken catenary pole

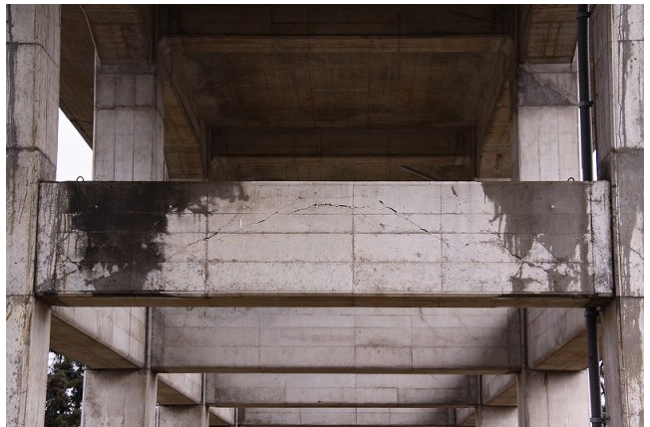
The 1<sup>st</sup>-story transverse beam: X-shaped diagonal cracking  
 Diagonal cracks were not observed on R3 on the facing side.  
 X-shaped diagonal cracks were found on R2 on the other side.

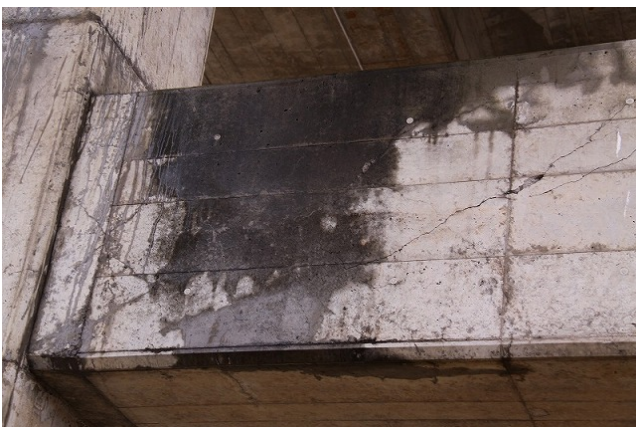
R2 1-story transverse beam: X-shaped diagonal cracking

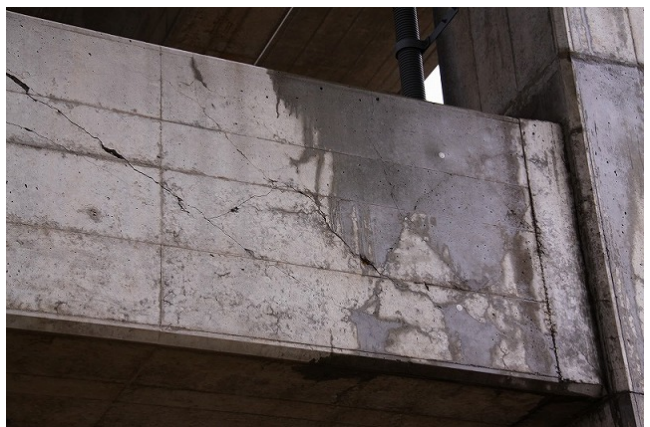
R2 1<sup>st</sup>-story transverse beam: X-shaped diagonal cracking

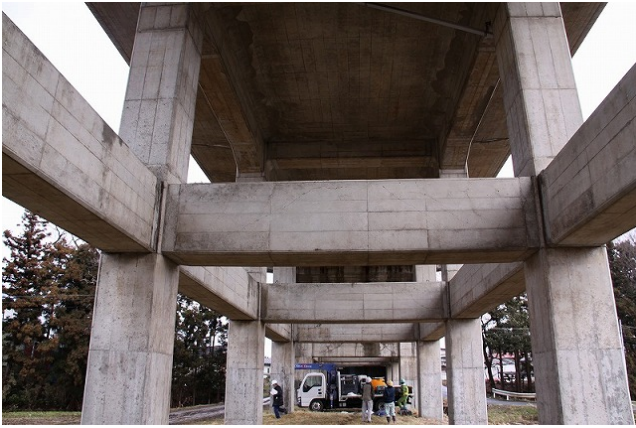
No. 2 Yachi BL  
R2 1<sup>st</sup>-story transverse beam: fine diagonal cracking

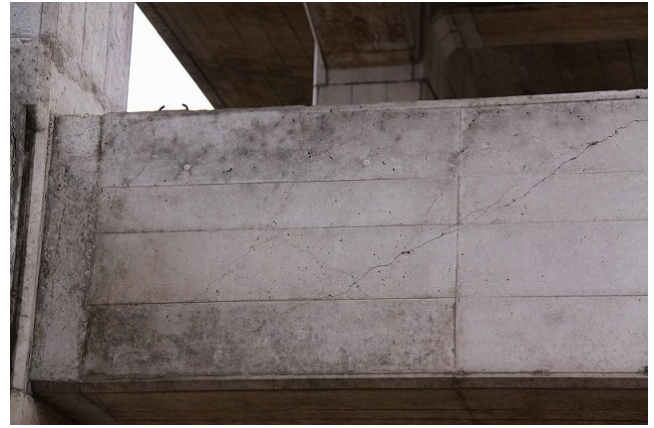
No. 2 Yachi BL  
R2 1<sup>st</sup>-story transverse beam: fine diagonal cracking

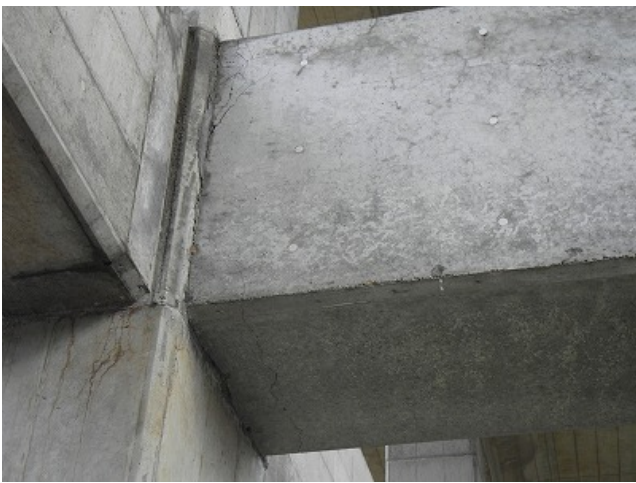
No. 2 Yachi BL  
R1 beam-column joint between 1<sup>st</sup>-story column and transverse beam: flexural cracking

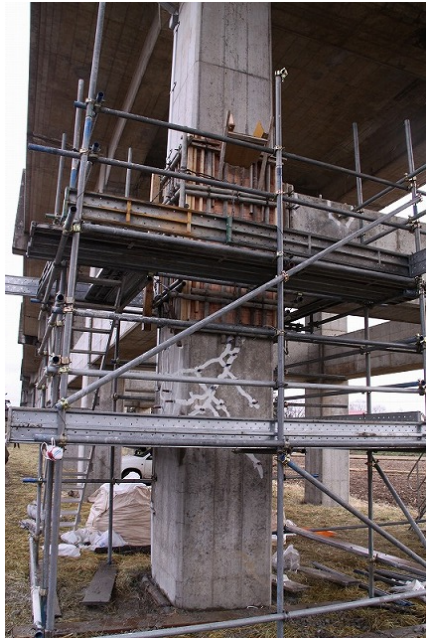
No. 2 Yachi BL  
R3 North-end column: damaged (and repaired)  
Joint: repaired by restoring the reduced cross-sectional area  
with grouting of the cracks  
2-story column: cracks grouted with resin

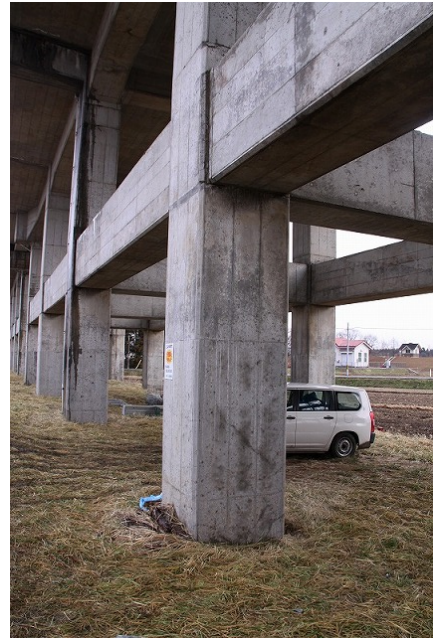
No. 2 Yachi BL  
R3 intermediate column at North-end: cracks found  
Diagonal cracks developed on the surface of the intermediate  
column in the longitudinal direction.

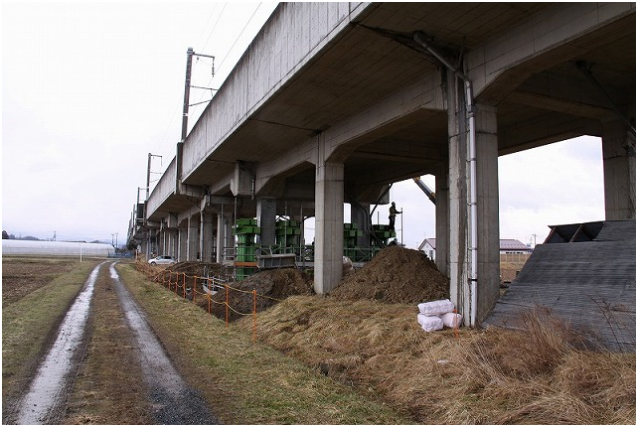
- R1 and R2 (Seismically retrofitted after damage): undamaged
- R3 (Not yet seismically retrofitted; cracks grouted after damage): cracks found.
- R6 and R7 (Not yet seismically retrofitted): damaged (and repaired)
- R4, R5, R8 and R9 (Not yet seismically retrofitted): undamaged

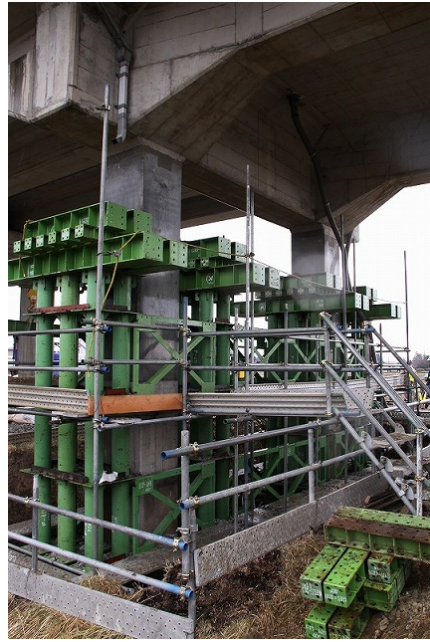
R7: Top column end damaged. Underwent emergency repairs.

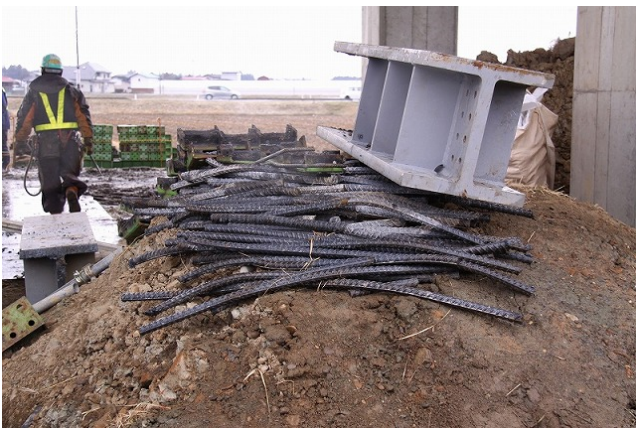
Unusable rebars were cut out and replaced with new steel reinforcement.

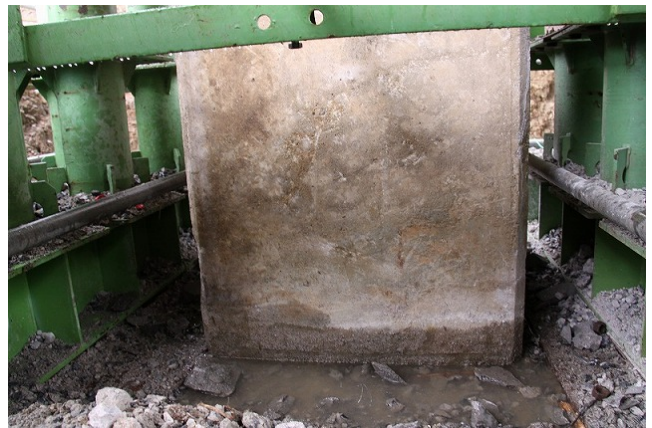
R7: Base of damaged column surface after the work of restoring column's cross-sectional area was completed (1.7 m below the ground surface)  
 Minor flexural cracking occurred. The top of the footing beam can be seen.

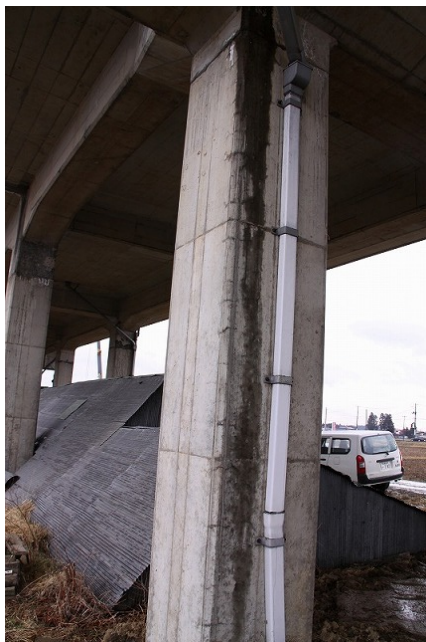
Details of longitudinal-facing surface of damaged intermediate column  
Narrow diagonal cracks developed.

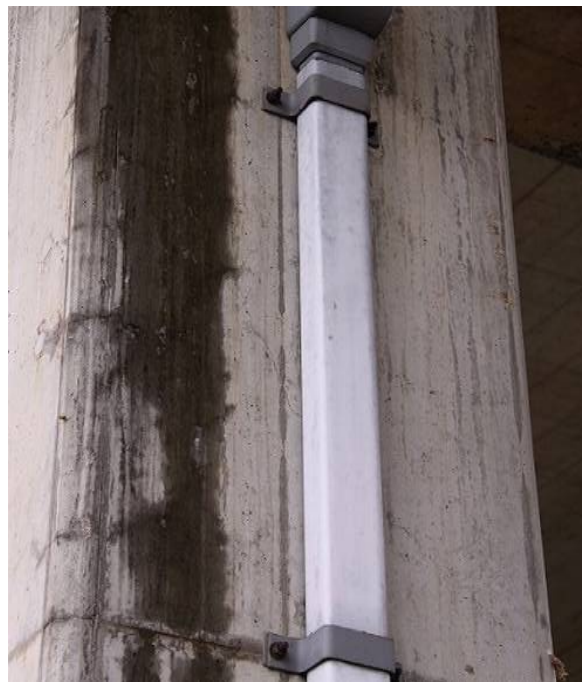
Closeup of the photo to the left  
Narrow diagonal cracks developed.

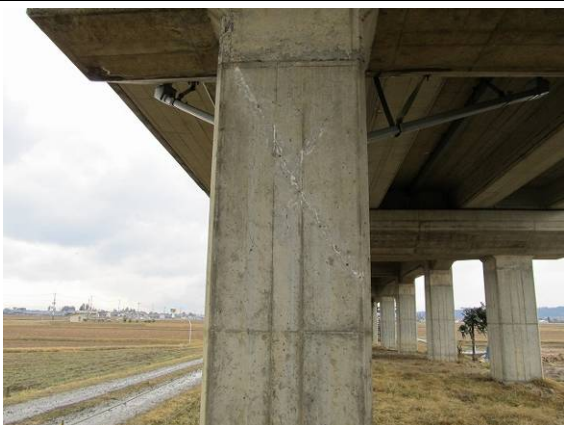
R3: Traces of cracks repaired by grouting were cracked.

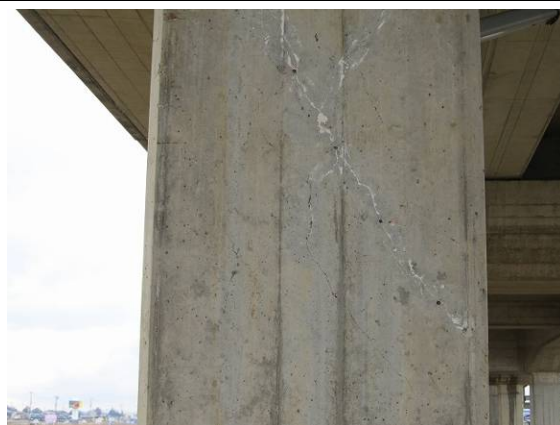
R3: Closeup of damage in photo at left

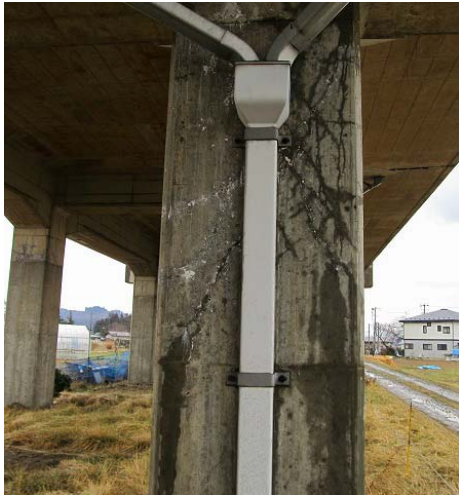
R3: The other side of the column shown above

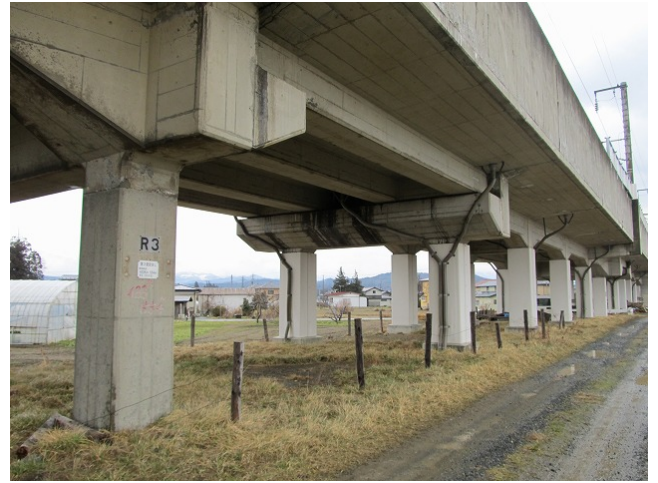
No. 3 Odagi BL  
R1 and R2 (Seismically retrofitted after damage): undamaged

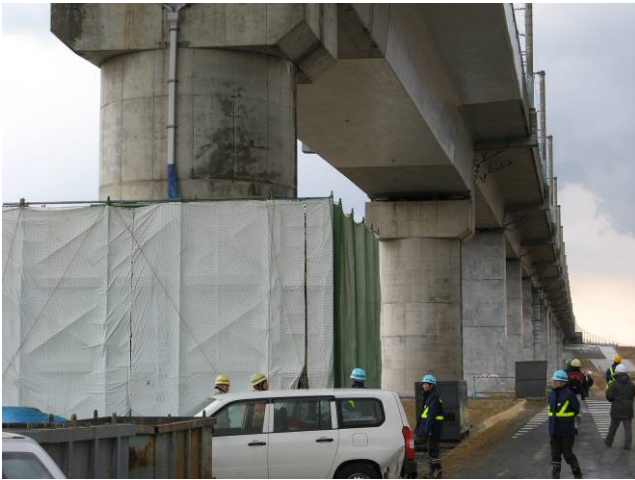
No. 1 Kitakamigawa Bridge

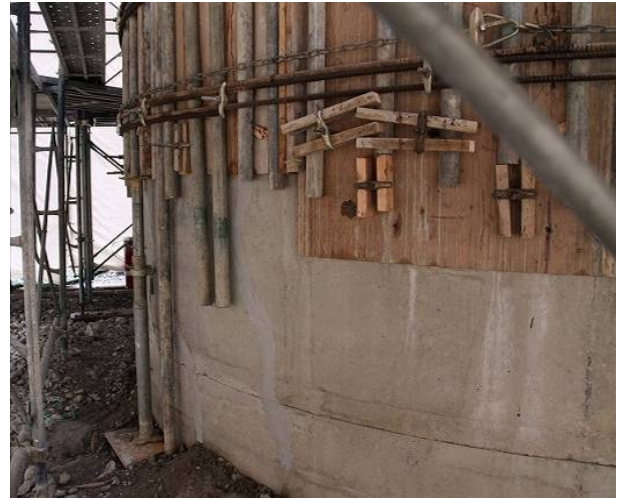
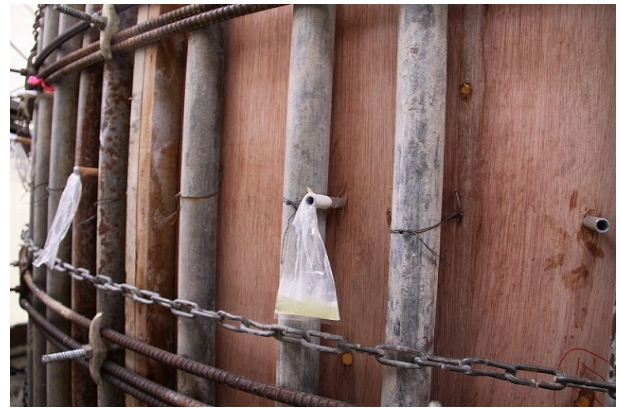
No. 1 Kitakamigawa Bridge

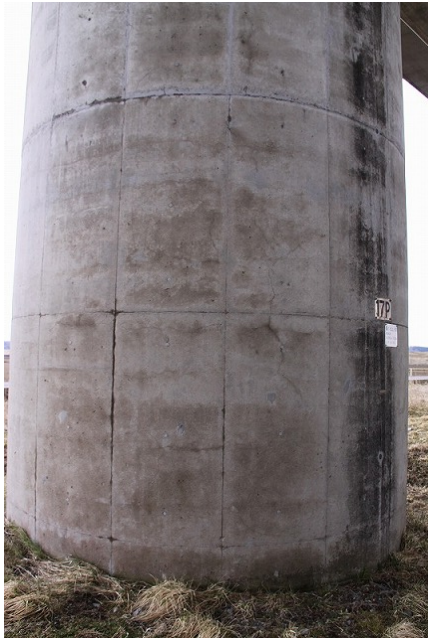
No. 1 Kitakamigawa Bridge  
17 P: Minor cracks near the welded place

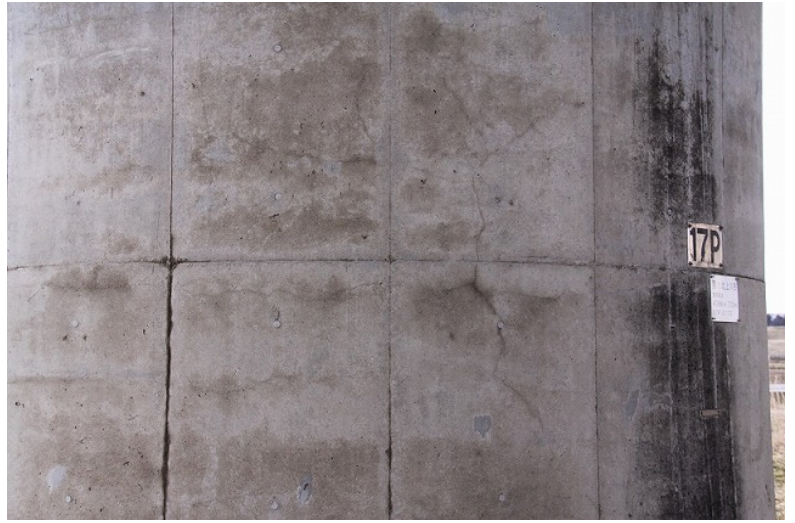
No. 1 Kitakamigawa Bridge  
17P: Minor cracks (Closeup of the photo to the left)

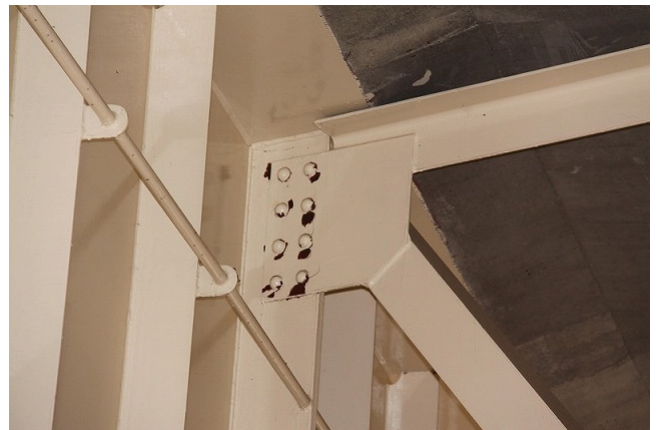
Toyosawagawa Bridge on the Tohoku Expressway: peeled paint film on a gusset plate above the support point on the bridge pier.

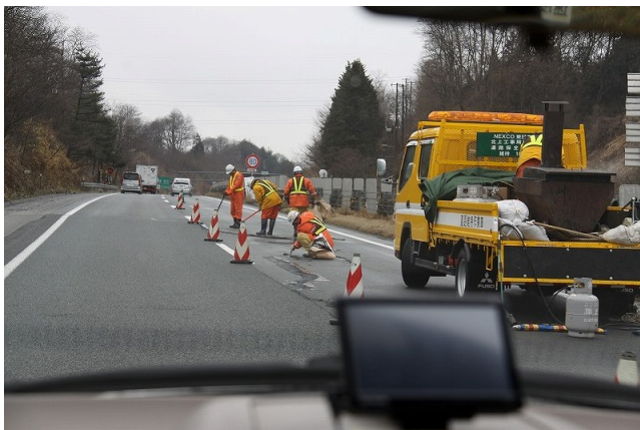
Cracked pavement (minor damage)

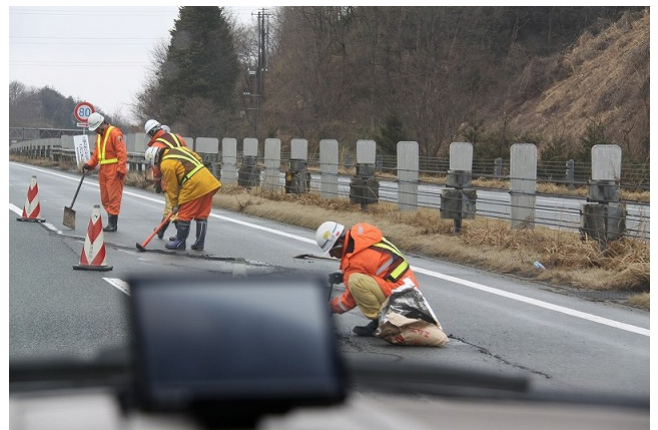
Cracked pavement (minor damage)

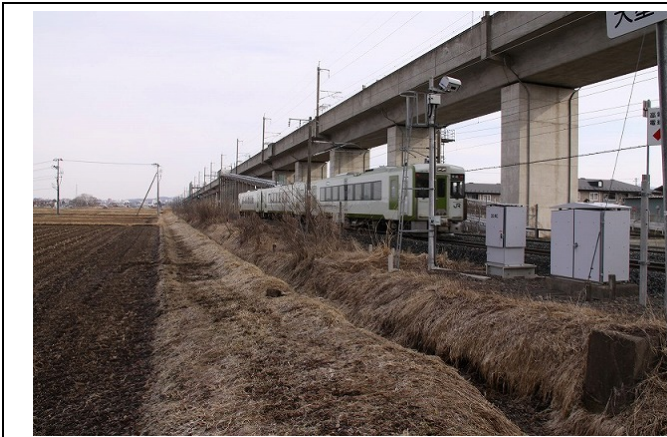
Near railway crossing around Iwate Iioka Station on the JR Tohoku line

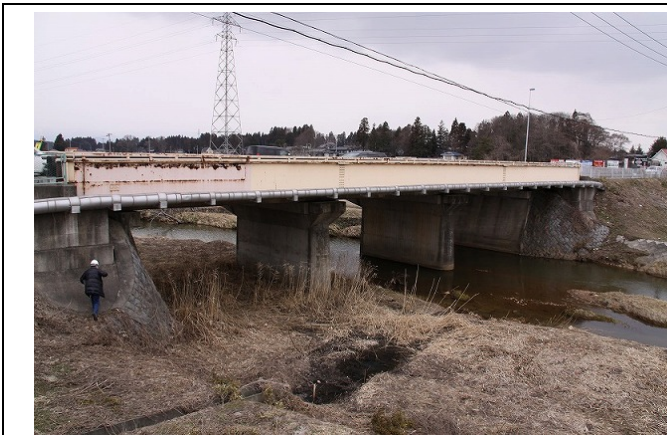
Iide Bridge on National Road No. 4

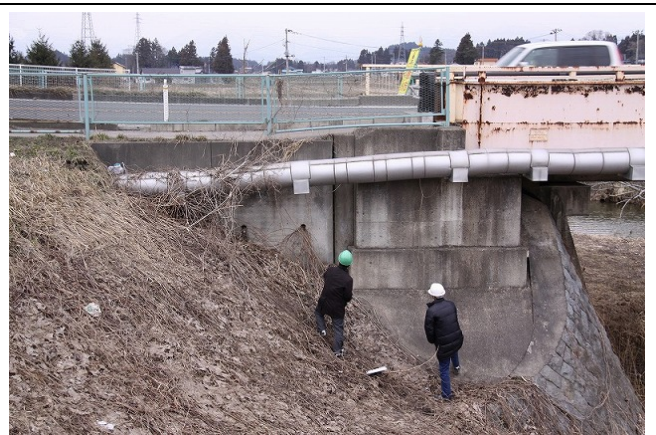
Iide Bridge on National Road No. 4

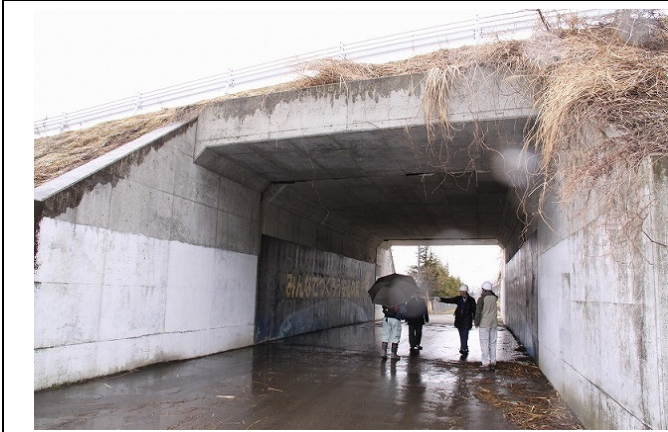
Farm road passing under Prefectural Road No. 205  
The culvert was displaced and the pavement had cracked.

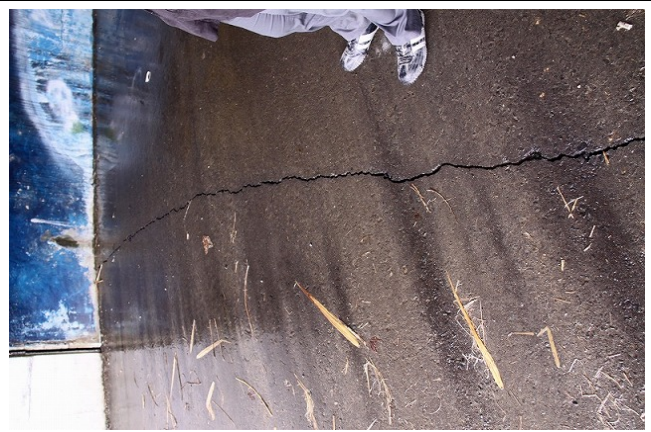
Cracked pavement in photo to the left

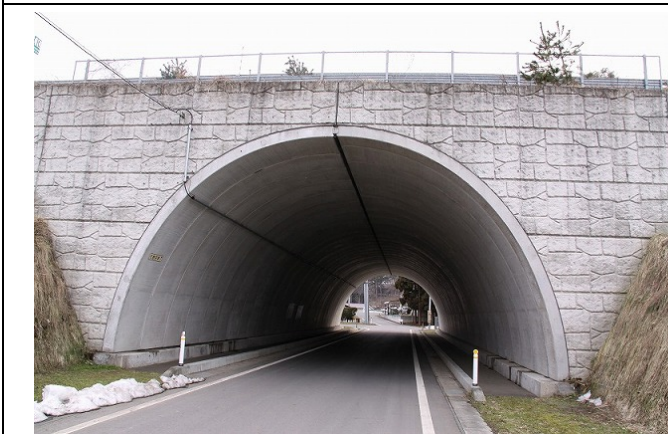
Precast three-hinge tunnel  
(Near Miyanome Bridge on the Kamaishi Expressway):  
undamaged
