Report by the First Joint Survey Team of the JSCE Concrete and Structural Engineering Committees on the damage caused by the Great East Japan Earthquake

April 5, 2011 (First Report)

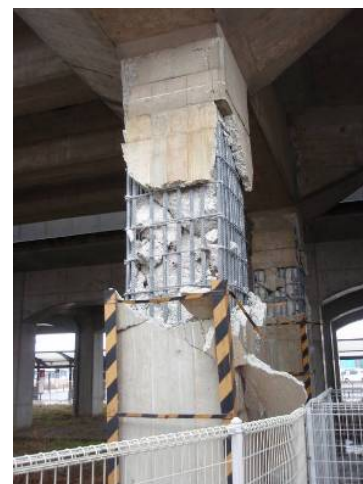
Fig. 1 Details of damage to the Naka Nagamachi viaduct (Source: East Japan Railway Company)

The Tohoku Shinkansen line and the local Tohoku line run adjacent to each other at the survey location. Damage to the RC rigid frame viaducts on the Tohoku Shinkansen line was similar to the damage seen after the 2004 Mid Niigata Prefecture Earthquake. A total of four columns at each end of the three-span rigid frame viaducts surveyed this time are shorter than the other four columns. This is because these four end columns have girder supports for the cantilever girders of the neighboring viaducts. These short columns consequently have a relatively small strength ratio (shear capacity / flexural capacity) and tend to fail. The most heavily damaged columns in the surveyed location were the columns at each end of the rigid frames. (Fig. 1)

Basically, seismic reinforcement of shear failure type columns of viaducts on the Tohoku Shinkansen line had been completed. The columns damaged by this earthquake were of flexural failure type with a small strength ratio. Nearby columns that had been seismically reinforced with a steel casing were undamaged.

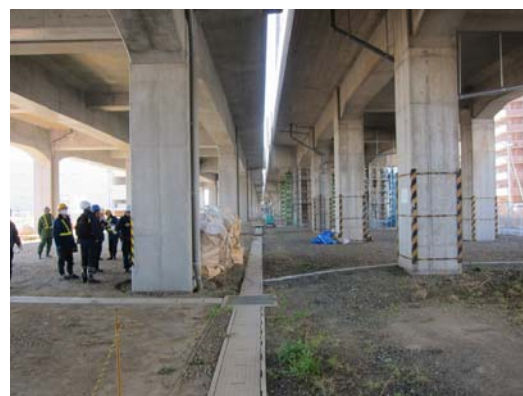
Fig. 3 Local Tohoku line (left) and Tohoku Shinkansen line (right)

The viaducts of the local Tohoku line running in parallel with the Tohoku Shinkansen line (Fig. 3) were designed in conformity with new seismic design standards based on lessons learned from the Great Hanshin Earthquake. The columns include spiral bars at the column hinge to provide them with a very high deformation capacity. No extensive damage was found to the columns of these viaducts, although flexural cracks were observed on the columns.

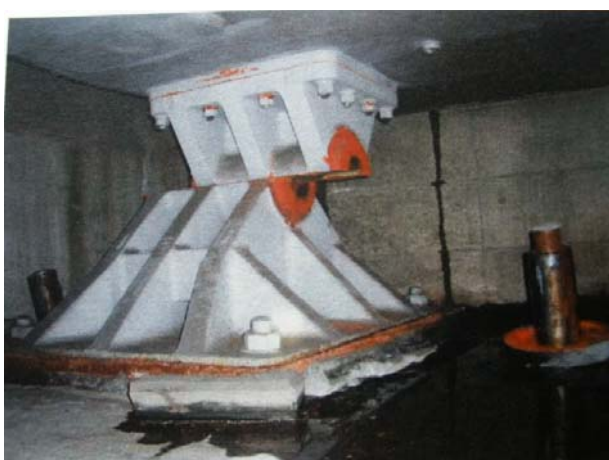
Fig. 2 Details of damage to bearing
(Source: East Japan Railway Company)

This bridge is a composite box girder bridge with a length of 74,500 mm. The earthquake motion caused breakage of the pin at the fixed parts of the bearings and there was a sideways movement of about half the width of the bearings. Repair work involving jacking up the girder had been completed by the time of this survey. The work was carried out without the need to close the national road running under the bridge, since there were concrete walls on both sides of bridge abutment and there was no possibility of the girders falling down.

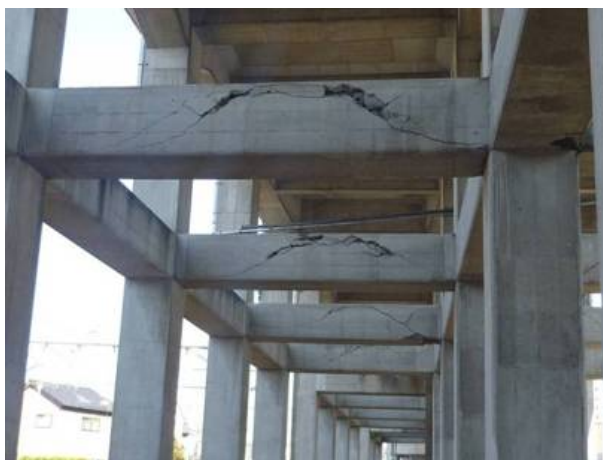
Fig. 1 Details of damage to block R1
(Source: East Japan Railway Company)

The survey location is near Sendai Station in the center of Sendai City. The columns of the viaduct had not yet undergone seismic reinforcement when the earthquake struck and the damage was found in the beams. The damaged middle-layer beams measure 1.1 m high by 6.5 m long by 1.2 m wide; they have no haunches. At a hearing prior to the survey, it was reported that diagonal cracking had occurred in two or more middle-layer beams in the transverse direction. Repair work had already been carried out so the cracks could not be visually checked during this survey. Since repair work had been completed, damage to R2 and subsequent blocks (adjacent to the one surveyed) could not be checked; however, a similar degree of damage was assumed to have taken place from observations of the repair work. Damage to concrete caused by the stoppers was observed on the girder supports at the ends of the rigid frame structures. Within the scope of the visual inspections, there was no noticeable damage to other members (such as middle-layer longitudinal beams, columns, column-beam joints, or slabs.)

Although shear cracking was observed in the middle-layer beams of this viaduct, the viaduct did not collapse. Similar damage has been observed after previous earthquakes. Deformation of the track was investigated in this survey.

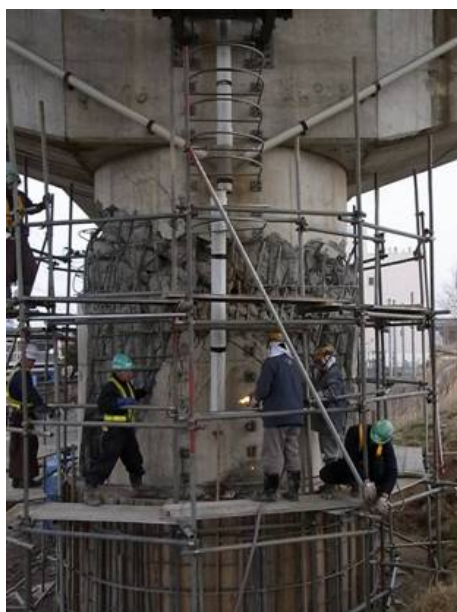
Fig. 1 Details of damage to bridge pier 4P of Iwakiri viaduct
(Source: East Japan Railway Company)

This viaduct carries the track over the local JR Tohoku line and consists of four piers. The damaged pier, at the end closest to the Furukawa station, had not yet been seismically reinforced when the earthquake struck. It was reported that, following flexural yielding of the bridge pier starting from the rebar cutoff point, concrete fell away as a result of failed cover concrete and shear cracking. (Fig. 1) Repair work by the RC envelope method had been completed by the time of this survey. (Fig. 2)

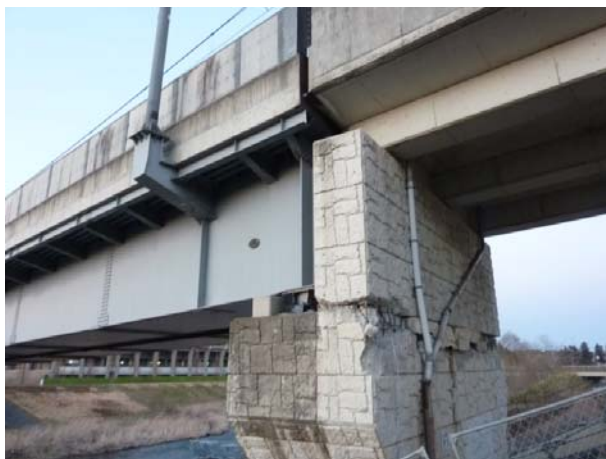
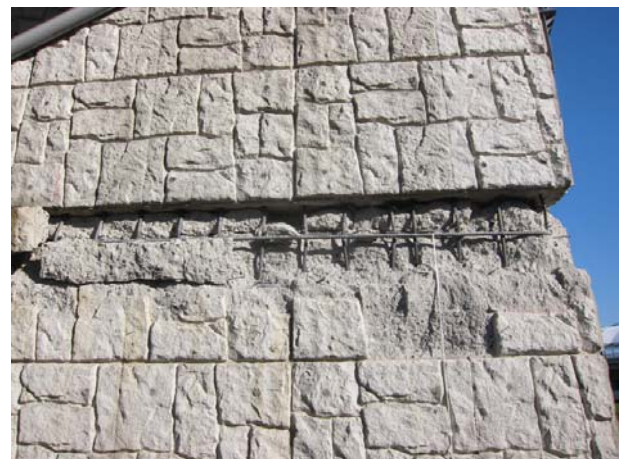
The breast wall at the rear (on the cantilever girder side) of the bridge abutment failed in flexure at the boundary with the lower part of the abutment, with buckling of the steel rebars and crushing of concrete. (Figs. 1.1 and 1.2) A possible cause of this damage was that cyclic loading applied on the breast wall, which supports the cantilever girder, and that the girder (considered in terms of design to have a free end) transmitted horizontal loading onto the wall. Looking at the damaged area, a concrete placing joint coincides with the boundary between the breast wall and the lower part of the bridge abutment. The bridge girder support on the opposite side of the abutment to the cantilever girder seems to have collided with the cantilever girder, causing chipping of the concrete.

Fig. 1.1 General view of damaged breast wall

Fig. 1.2 Details of damage to the breast wall

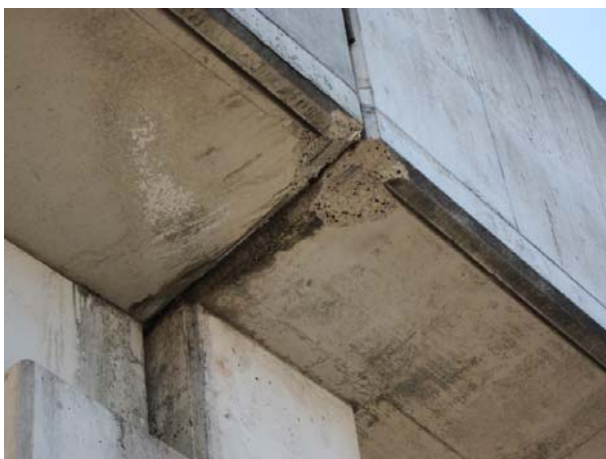
Fig. 1.3 Damaged cantilever girder

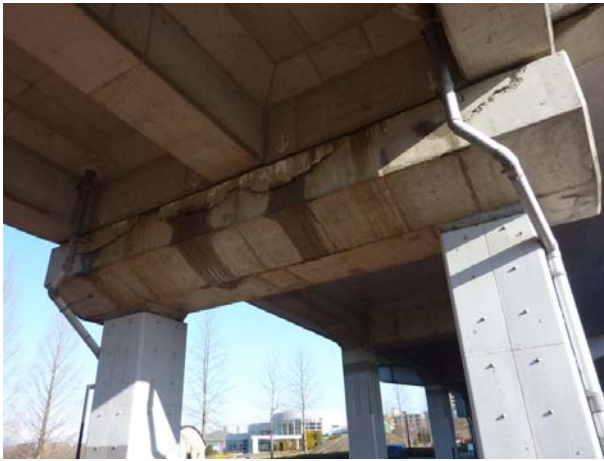
At the rigid frame bridge piers at the opposite end of the girder to the pier described above, concrete broke away from the corner of one bridge pier support for the cantilever girder. (Fig. 2) The cause of this damage was that the cantilever girder bearing was not completely free in the horizontal direction and horizontal seismic loading was transmitted to the bearing. This caused the concrete to crack.

Fig. 2 Damaged girder support

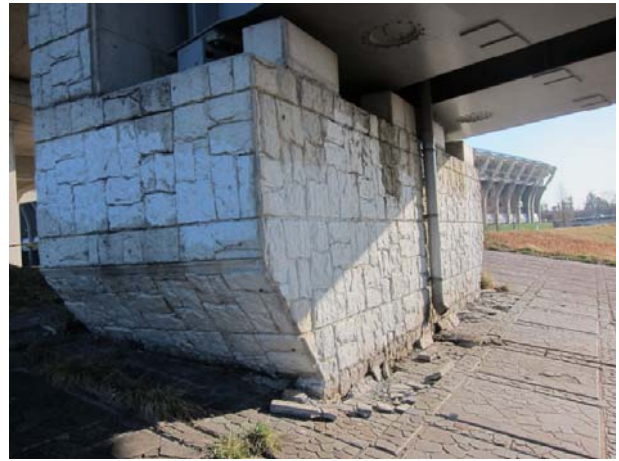
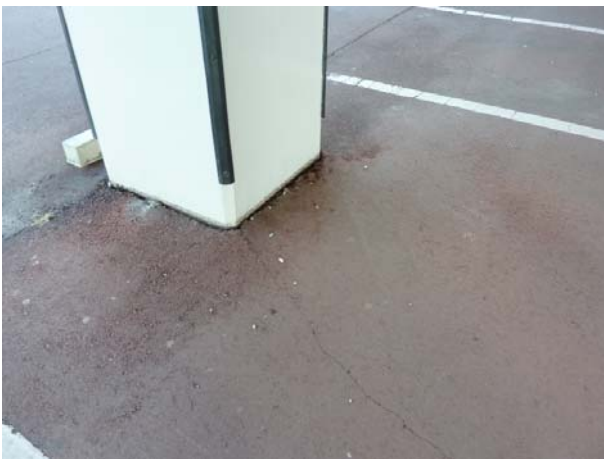
Cracking due to deformation of the ground was found in at least two bridge piers and column bases. (Fig. 3)

Fig. 3.1 Deformed ground (Nanakitagawa bridge, Izumi Chuogawa abutment)

Fig. 3.2 Cracking at the column base of rigid frame viaduct

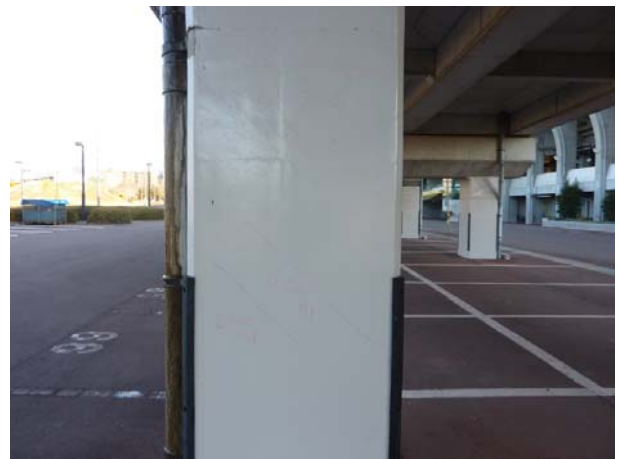
Minor shear cracking was observed in a column of the rigid frame viaduct.

Fig. 4 Shear cracking in column of rigid frame viaduct

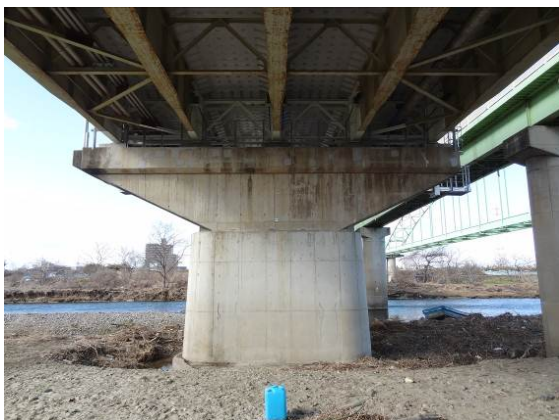
Fig. 1

The piers of this bridge had already undergone seismic reinforcement by the RC envelope method. The seismic reinforcement had been applied to the section of the bridge piers below the rebar cut-off plane. (Fig. 1)

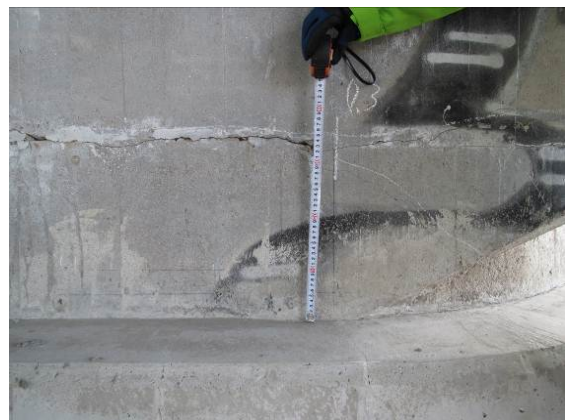
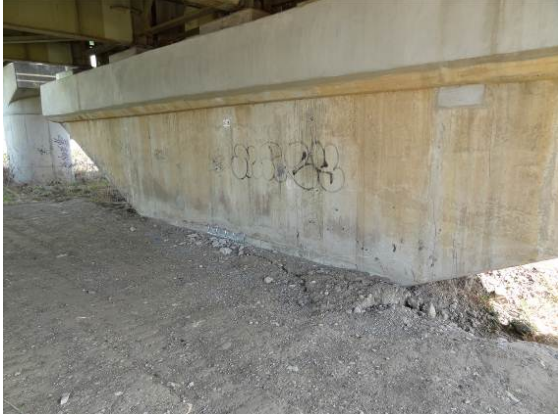
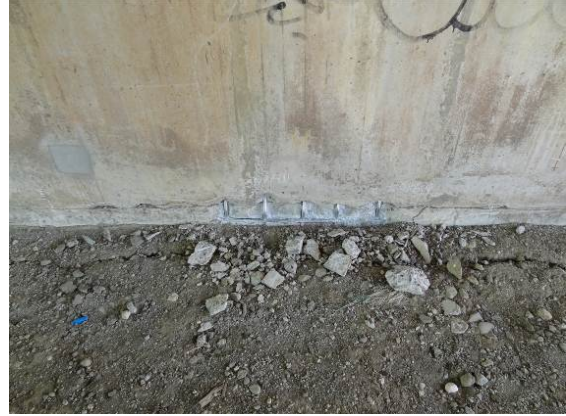
Cracks measuring from about 0.3 mm up to 5 mm in width had developed in the horizontal direction at locations about 30 cm above the top end of the RC envelopes that had been added to seismically reinforce the RC bridge pier. (Fig. 2) At bridge pier P16 on the Sendai end of the bridge, part of the cover concrete broke away and rebars in the axial direction buckled. (Figs. 3 and 4) This buckling of rebars in the axial direction occurred where there was single spacing of tie hoops. A possible cause of this damage was that the top end of the seismic reinforcement RC envelope (at the point where the cross-sectional area begins to change to form the rebar cut-off plane) weakened and flexural cracking developed as a result of the inertia force of the superstructure.

Fig. 4 (Closeup of the damaged portion in Fig. 3)

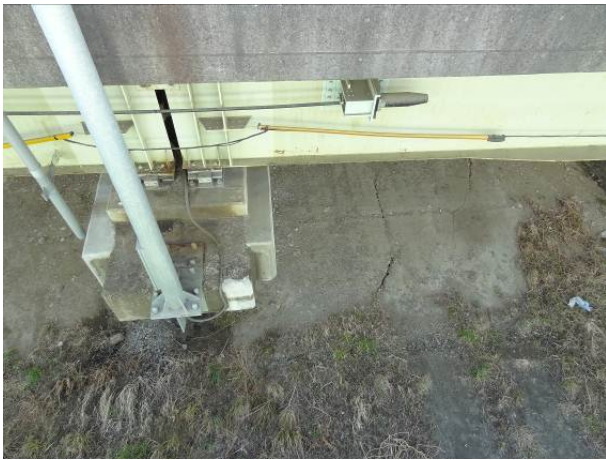
Fig. 5

Cracks in the ground due to the response of the bridge piers to earthquake motion were observed around bridge pier P16, where the seismic reinforcement RC envelope was completely under the surface. (Fig. 5)

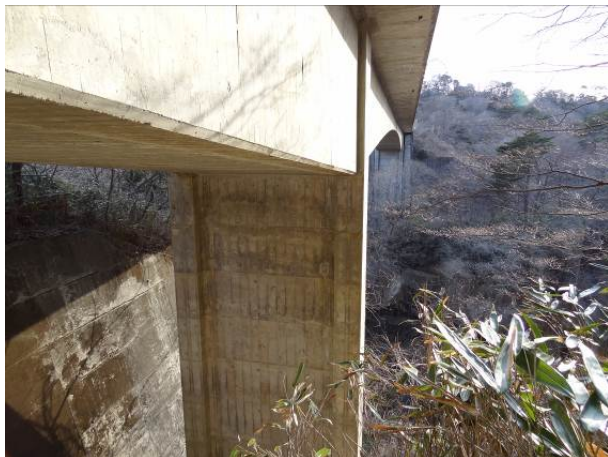
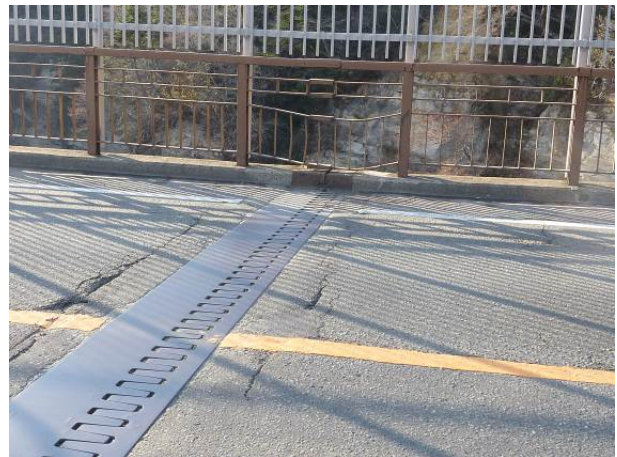
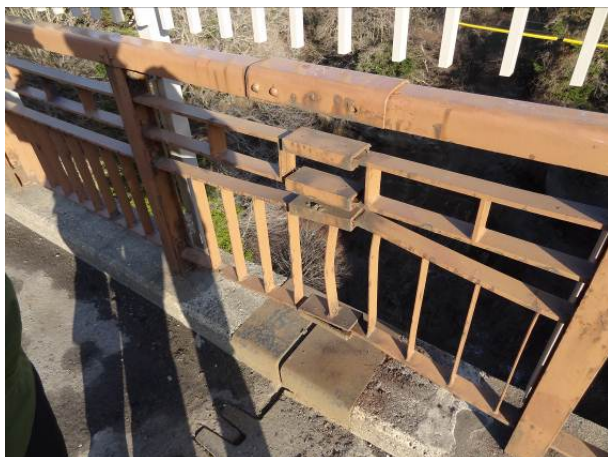
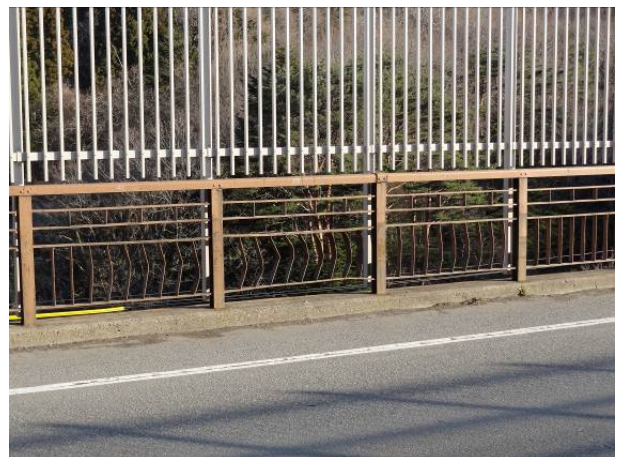
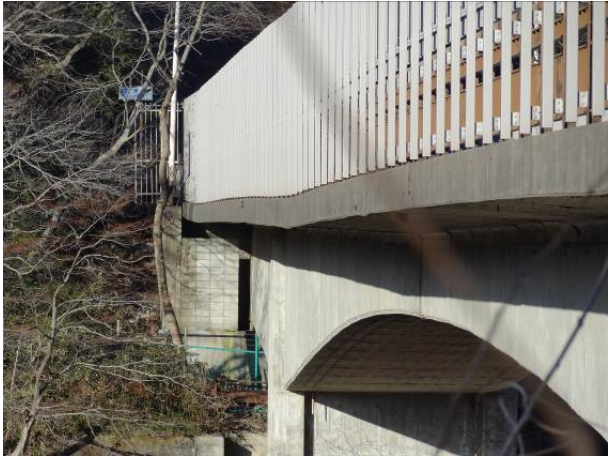
Within the limitations of visual inspection from a distance, no major damage to bridge piers or girders was apparent. (Fig. 1) Deformation of the steel bridge railings was found around the center of the span. (Figs. 2 and 3) This railing deformation was probably caused by the three-hinge arch structure before the earthquake. Deformed railings were also observed in other bridge sections. (Fig. 4) There was no sign of significant deformation at the joint in the center of the span. (Figs. 2 and 5)

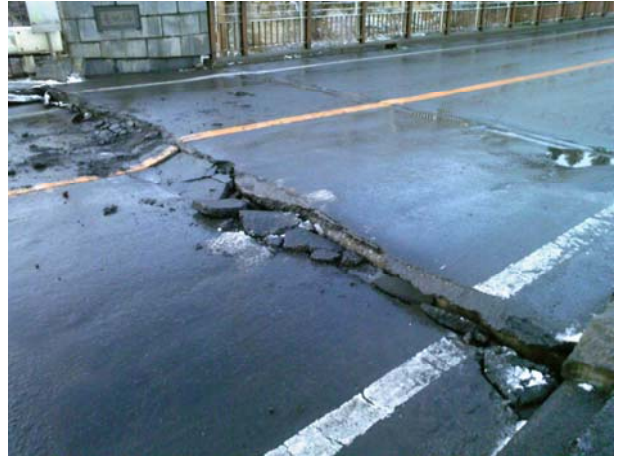
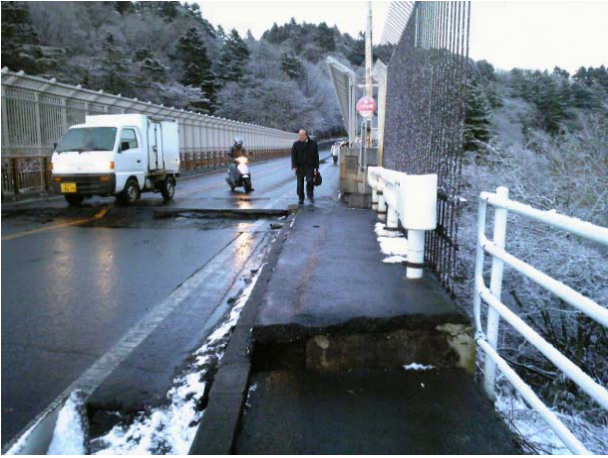
There was a drop in the level of the road surface due to ground subsidence at the rear of the bridge abutment on the Yagiyama side. (Figs. 6 and 7) This had already been repaired with asphalt and the road was open at the time of the survey. (Fig. 8)

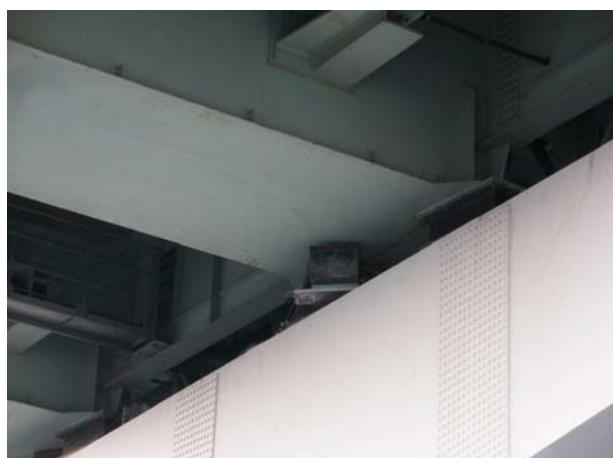
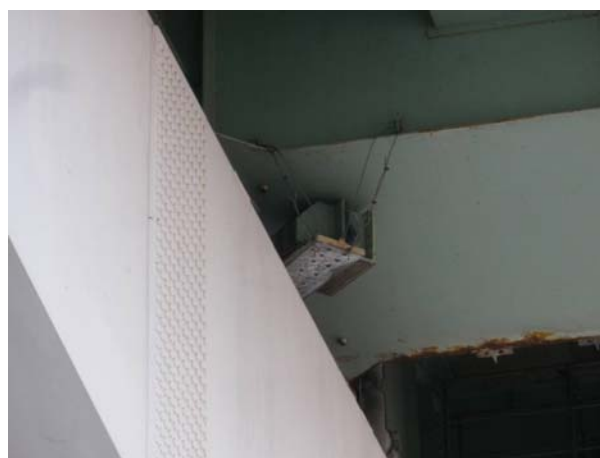
The Sendai East Highway is a north-south expressway crossing the eastern part of the Sendai Plain. Prefectural road No. 10 runs under the elevated expressway. It was reported that the area near the Sendai Kohoku IC had been damaged by the tsunami, but at the survey point about 1.5 km south of the IC, no earthquake damage was observed to RC or steel bridge piers. Within the limitations of visual inspection, no damage was found to the superstructure. (Figs. 1 and 2) The on-site visual inspection identified that a device designed to restrict the movement of a girder in the transverse direction was displaced. (Figs. 3 and 4)

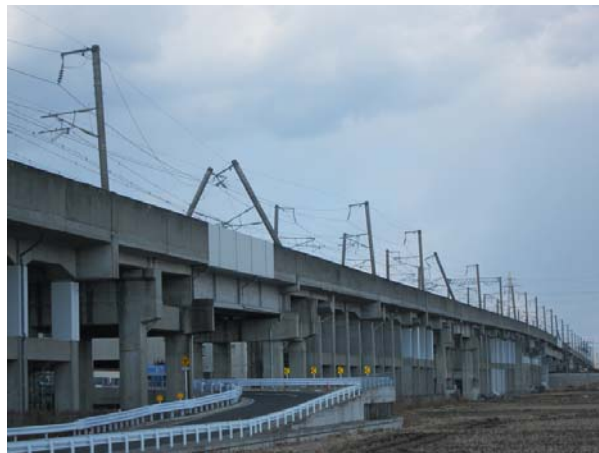
About 470 catenary poles are reported to have suffered failure, tilting, or cracking along the Tohoku Shinkansen line (as of March 18). (Fig. 1) Catenary poles had been damaged (failure, tilting, and cracking) in previous earthquakes, but the damage caused by this one was greater and more extensive than ever before. The repair of catenary poles and wires will take a long time, although restoration of civil engineering structures related to the Tohoku Shinkansen line is expected to be completed relatively soon.

Fig. 1 Damaged catenary support poles on the Tohoku Shinkansen line
