Renovation of the Genta Bridge: Increasing the Lane Width and Load Resistance

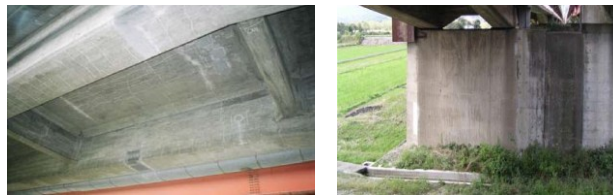
Photo 2. Superstructure and substructure before renovation

After over 60 years of operation, the bridge was aging and declining in function and load resistance. However, a preliminary investigation revealed that the concrete strengths of the bridge legs and main girders were high— $25\text{--}48\text{N/mm}^2$ and $36\text{--}54\text{N/mm}^2$, respectively—and corrosion and cracking were minor (Photo 2). Moreover, neutralization had progressed slowly and the chloride ion concentrations were low. Hence, the bridge could be renovated rather than replaced.

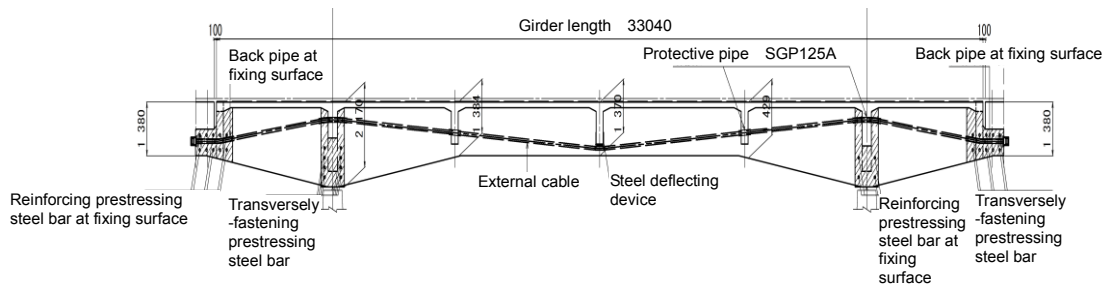
Figure 3. Reinforced section with external cables

The design live load of the bridge was T-9 load, which was increased to A live load in order to accommodate the increased traffic of large vehicles. To reinforce the bending

strength of the main girders, five 1650 kN-type external cables were arranged in each span and prestressed (Figure 3 and Photo 3).

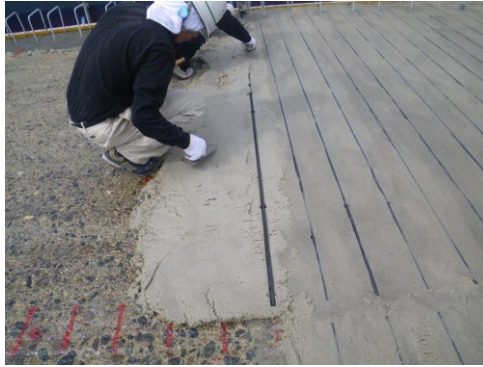
Photo 6. Reinforcement of upper surface of floor slab

The floor slab was reinforced in order to compensate for insufficient bending strength and shear capacity resulting from the greater width and increased wheel load of the floor slab.

Reinforcement methods that produce only a small increase in the dead load were compared. For reasons of constructability and economy, the CFRP (Carbon Fiber Reinforced Plastic) rod method was employed to reinforce the upper surface of the floor slab (Photo 6). This method resulted in a greater decrease in the weight by 12 kN/m than would have been possible with general additional floor slab casting methods.
