ASSESSMENT OF PC BRIDGE BASED ON TESTING REMOVED BEAM AGED FOR 40 YEARS

Keiichi AOKI, Shinya WATANABE, Takashi SANGA, Kenichi MIYANAGA
and Hiroshi MUTSUYOSHI

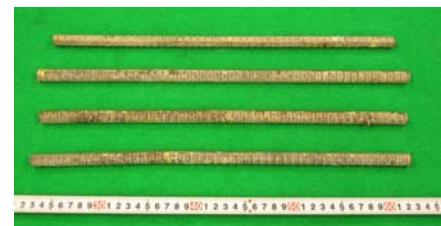
Photo 3 Rebar test pieces

The cover concrete was chipped away to remove sections of main rebar from under the flange at the span center. Tensile tests were carried out on the removed rebars (D13). All test pieces met the Japan Industrial Standard (JIS). Furthermore, no corrosion or pitting caused by aging were noted.

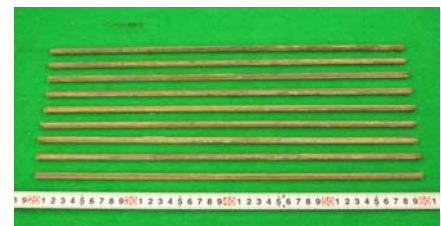
Photo 4 Post-tensioning wires (C2 wires)

Cover concrete, steel sheath, and PC grout were removed from the span center and the tensioning wires extracted. Photo 4 shows the removed wires. Red rust, but no pitting corrosion, was identified on the wires.

Tensile tests were carried out on four of the wires. The Specifications for PC Highway Bridges set the allowable elongation at over 5%, but the three of the tested wires exhibited elongation of no more than 5%. Therefore, we also figured elongation inferior 0.5% by aging.

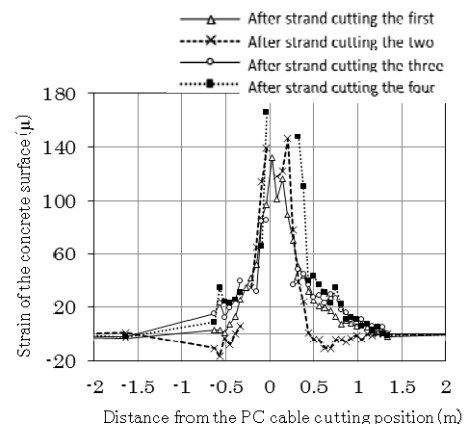
Fig. 3 Influence of cutting tensioning wires

Figure 3 shows how the strain on the concrete surface under the PC girder increased as the first to fourth wires were cut.

The area influenced by cutting the first and second wires were from $\pm 300 \text{ mm}$ to $\pm 1200 \text{ mm}$, as indicated by the increasing strain level. This area of influence became $\pm 1500 \text{ mm}$ upon cutting the third and fourth cables. The previous report on cutting PC wires stated that the influenced region is almost the same as the effective bond length of the PC wires (in this study, 65ϕ). The influence of cutting the wires in this test was confirmed to extend over this length, which might have been caused by the packing condition of the grout. That is, one of the causes of the widespread influence may be lack of grout packing.

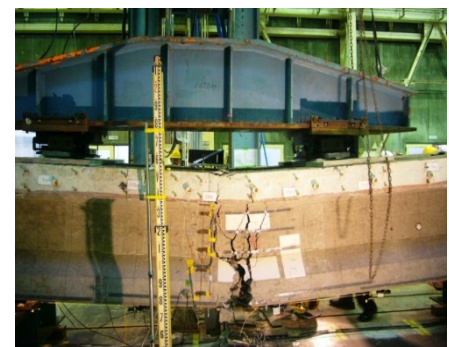
Photo 6 Situation at failure

The beam was tested to failure after the fourth wire was cut. The crack width in the center quickly increased. The girder then broke apart, accompanied by the sound of parting wires and rebars, when the load was about 168 kN and the deflection was 199.48 mm. Photo 6 shows the situation after failure.

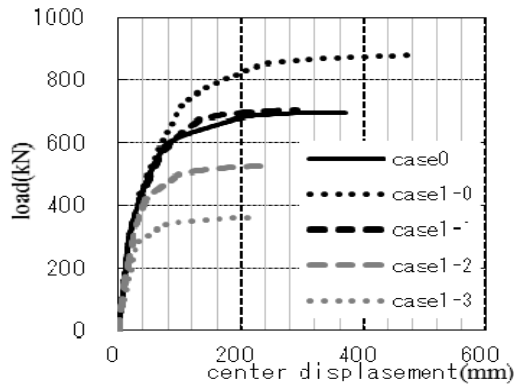
Fig. 4 Load-displacement relationship

The result of analysis indicates that, in the cases 0 and 1-0, crushing of concrete causes the rupturing of PC wires in the girder. In the cases 1-2 and 1-3, two PC wires in the girder were ruptured due to the crushing of concrete.

The design live load at the time of construction (TL-20) was 149.1 kN. The current value of design live load (the B-live load) is 166.0 kN. The case with the experimental material model in which three post-tensioning wires were cut (Case 1-3) indicates that the ultimate load remains higher than the design load.

Consequently, the flexural failure load of the case in which three PC wires are ruptured is still higher than the ultimate design load specified in the Specifications for Highway Bridges, Japan Road Association. Safety against failure is therefore satisfied when the actual experimental values are selected for the material model.
