Investigation report on Kumamoto earthquake

Name of investigation team “Investigation concerning Higher Durability and Quality of Reconstructed Infrastructure after Kumamoto earthquake” (JSCE concrete committee)

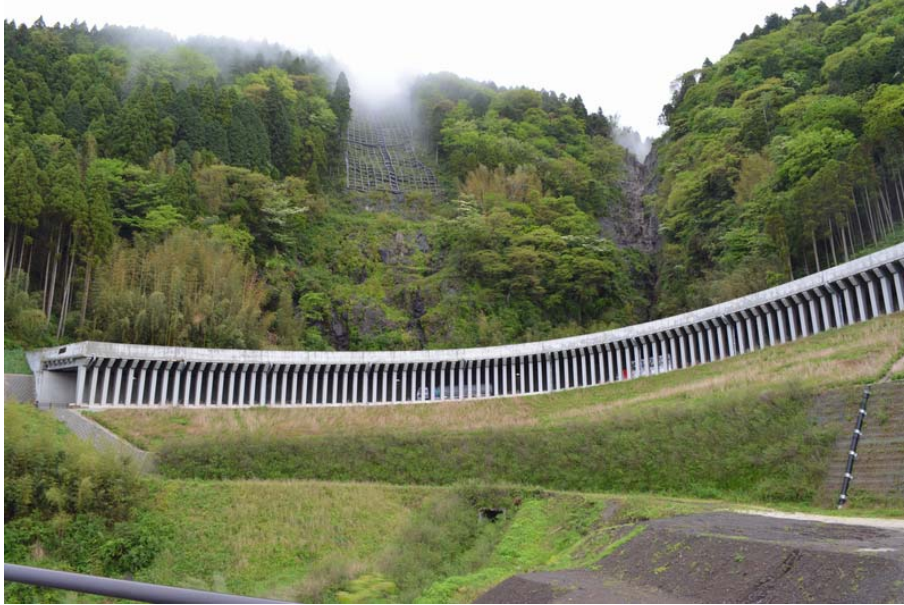
Photo 2 Rock shed and slope protection structures near to the beginning of the Takimurozaka section

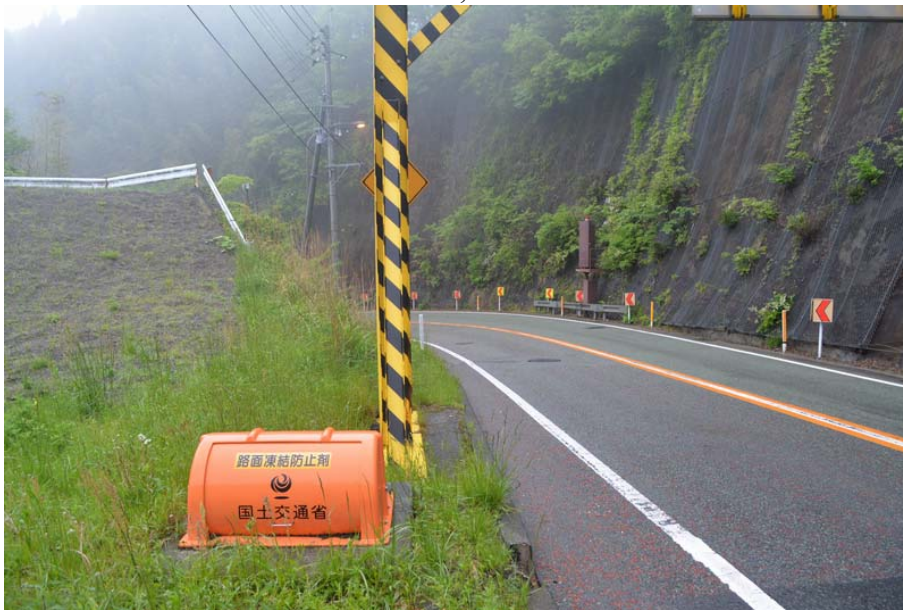
Photo 3 Surface antifreeze agent storage container

Photo 3 shows an antifreeze agent container on the Takimurozaka section.

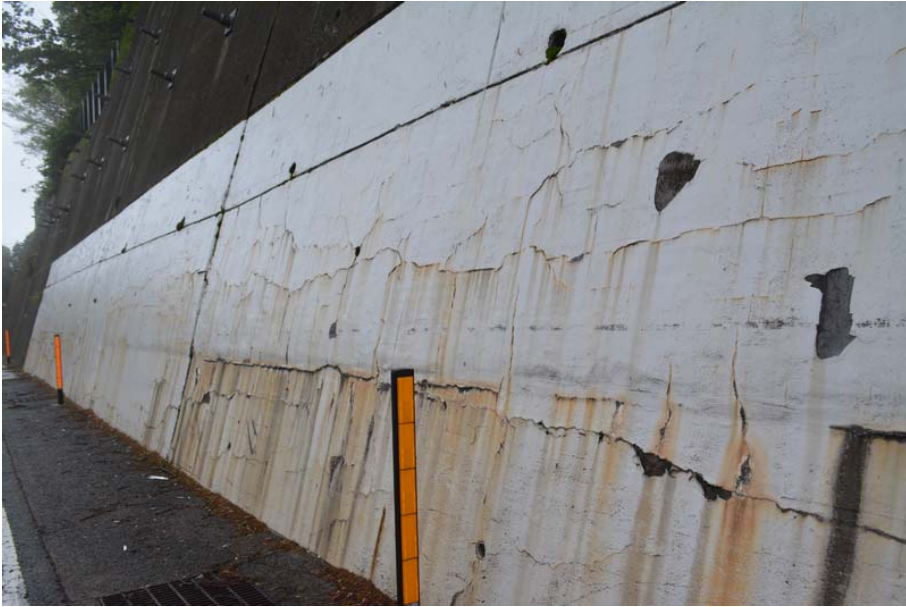
Photo 4 Deterioration of retaining wall possibly due to ASR

Photo 4 shows a roadside retaining wall exhibiting signs of deterioration of the liquid membrane applied in earlier repair work, possibly due to the ASR. Possible causes include the reactivity of the aggregates used in the concrete, sodium originating from the antifreeze agents, or the supply of alkalis from soil behind the wall. The need to curb the ASR is clear.

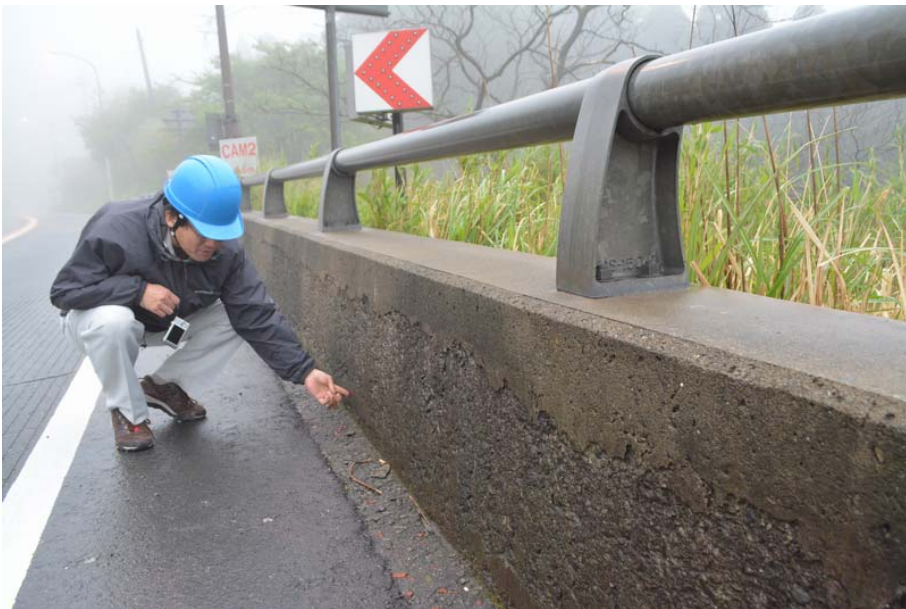
Photo 5 Deterioration of safety barrier due to freezing damage

Photo 5 shows the deterioration of a safety barrier along the Takimurozaka section, probably caused by freezing damage. There are reports that antifreeze agents promote

freezing damage to concrete. This deterioration of a safety barrier may also have been accelerated by the use of antifreeze agents.

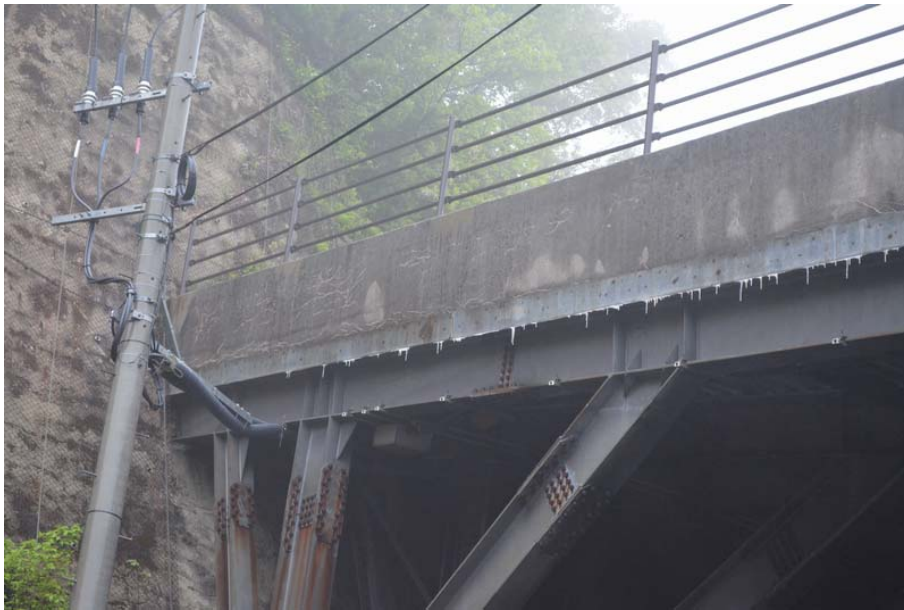
Photo 6 Deterioration at entrance to rock shed, middle of Takimurozaka section

Photo 6 shows the deterioration at the entrance to a rock shed around the middle of the Takimurozaka section. Cracking has developed in the concrete in a horizontal direction, causing cement gel to leak from inside. A visual inspection indicates that the cause of the deterioration could be a combination of slight freezing damage and the ASR. Corrosion of steel members and high-strength bolts was also observed.

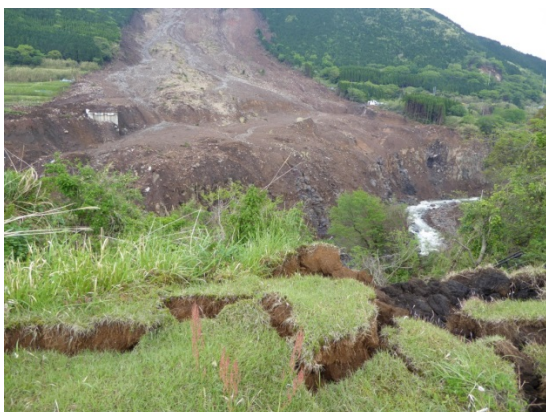
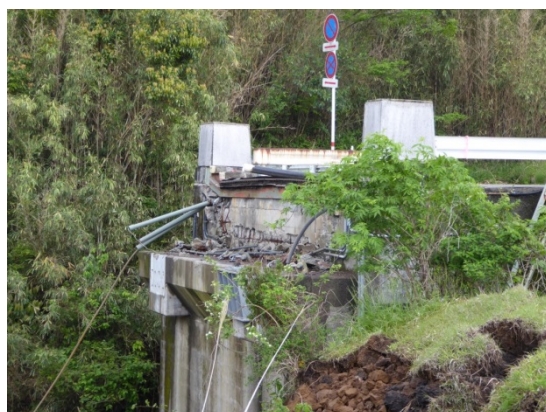
14:30 Aso Bridge (type: arch bridge with inverted-Langer girder deck truss; total length: 205.9m; main span: 132.2m; width: 8m; constructed in 1970).

Damaged state:

Total collapse, possibly due to widespread failure of mountainside (but possibly as a direct result of the earthquake). The fall prevention system was destroyed. National Route No. 57 over the bridge was cut off and the alternative “Milk Road” was serving as the road link from Kumamoto via Aso to Oita.

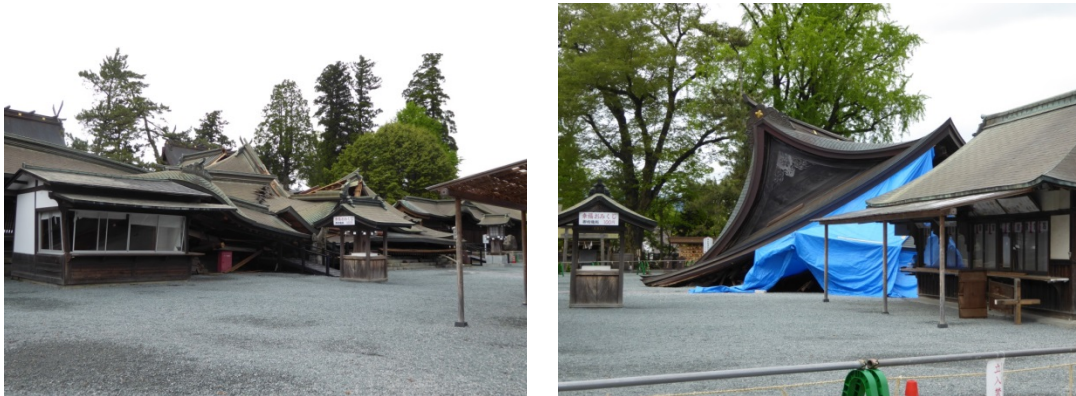
Aso Shrine

“Romon Gate”, which is designated by the government as an important cultural property, was completely destroyed. The shrine buildings also collapsed.

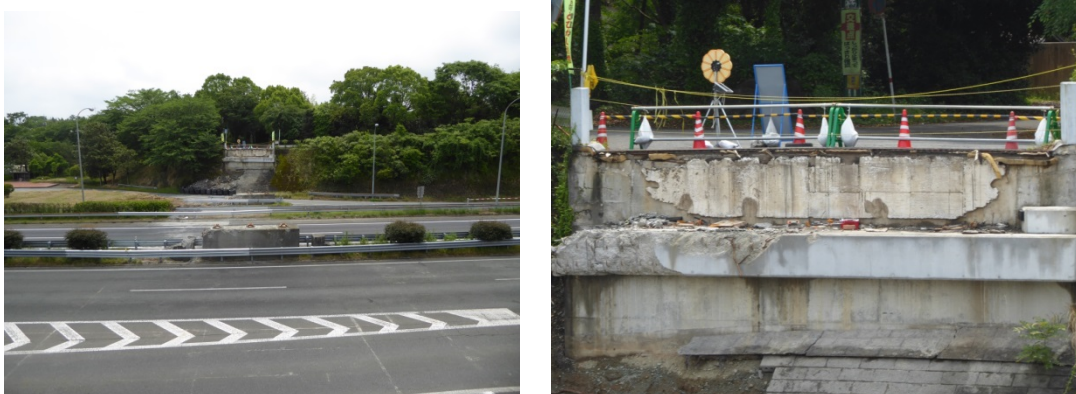
11:00 Furyo-daiichi Bridge (type: prestressed concrete three-span continuous hollow floor slab bridge; total length: 61m; constructed in 1974). The bridge crosses the Kyushu Expressway near the Midorikawa parking area.

The bridge, with rocking piers, spans the Kyushu Expressway. The on-site evidence (including the way in which the horizontal restraining members and shoe seat surfaces had failed) indicates that the bridge collapsed to the left in the photo. The girder had been removed and the Kyushu Expressway resumed full operation on April 29 (15th day after the disaster).

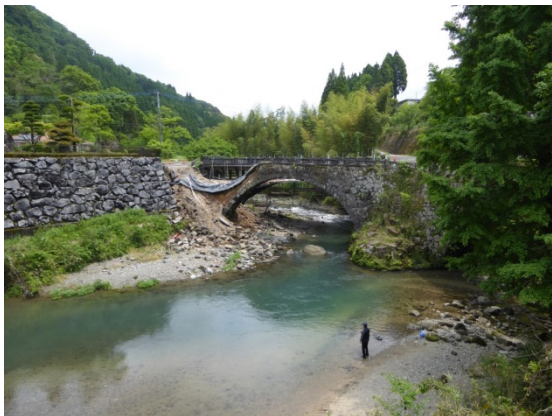
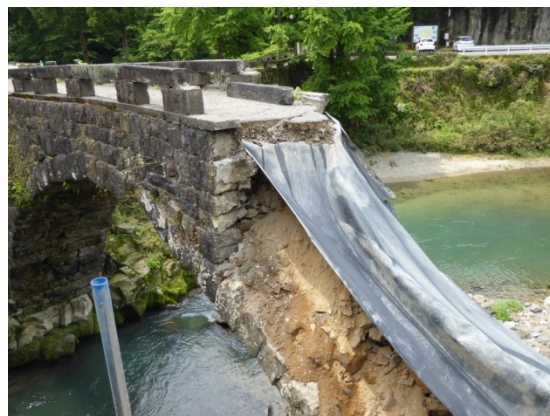
12:00 Futamata-fukurawatashi Bridge (type: masonry arch bridge; total length: 27m; constructed in 1830).

The stones forming the wall toward the top of the arch crumbled in the earthquake. A twin bridge nearby, the Futamata Bridge, had no visible damage. The difference can be assumed to be due to the direction of the earthquake motion. The waterproof sheet visible in the photographs was installed by the bridge manager a few years ago to prevent the entry of storm water.

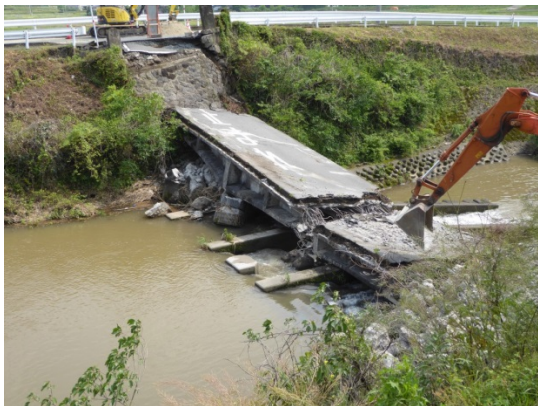
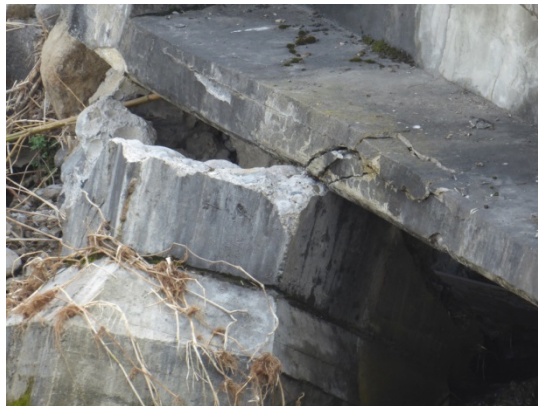
14:30 Bridge of unknown name (type: girder bridge total length: about 15m; construction year: unknown)

It can be assumed that failure of the plain concrete piers resulted in collapse of the bridge. The girder consisted of round-section steel. Demolition work was under way at the time of the inspection.

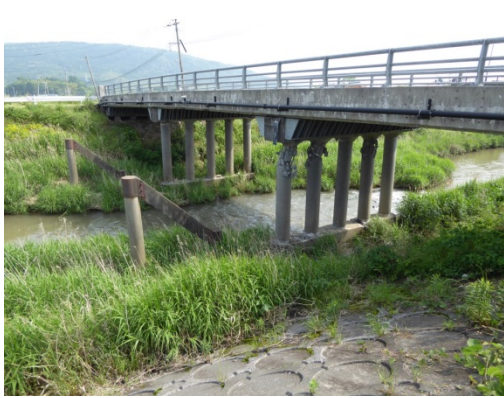
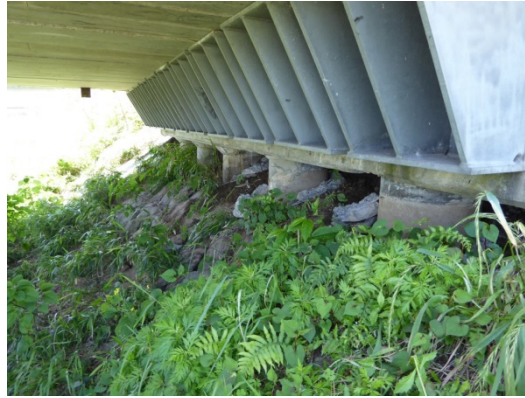
15:00 Daiichi Hatanaka Bridge (type: girder bridge; constructed in 1976)

Serious damage was concentrated at the top and bottom of the circular piers. It is possible that the amount of hoop reinforcement is small. No damage was observed to the girder. The road was closed to traffic.

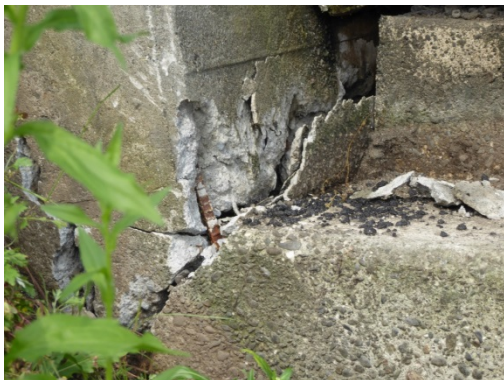
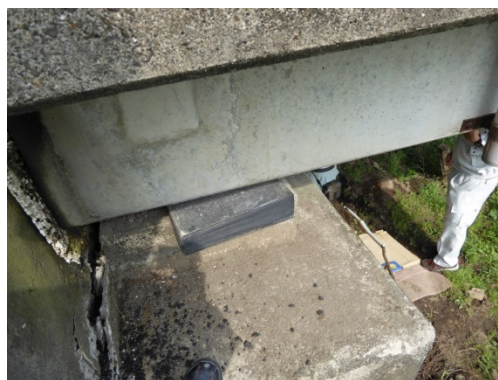
15:30 Miyazono Bridge (type: girder bridge; total length: about 15m; constructed in 1977).

The rubber pads (used in place of shoes) bearing the girder were visible, which indicates that the bridge had shifted in the direction perpendicular to its axis due to the effect of the earthquake motion. The lower part of the parapet collapsed. The amount of main reinforcing steel is small. The road continues to be in service.

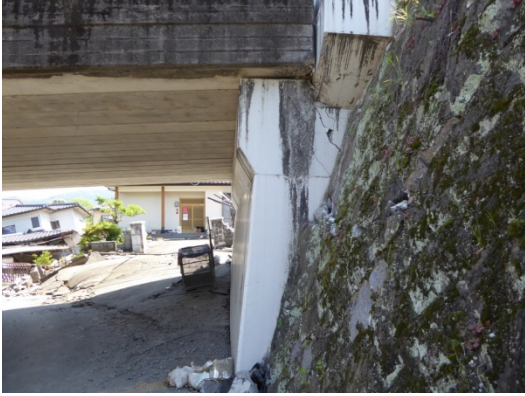
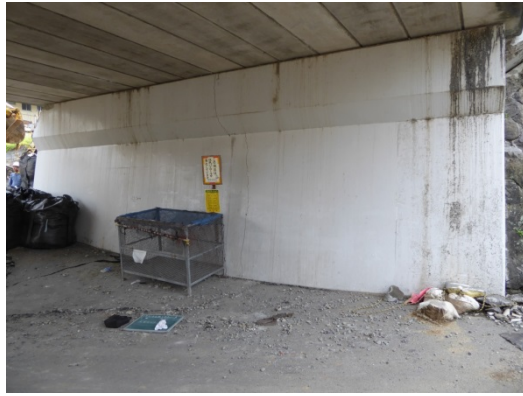
15:30 Terasako Bridge (type: girder bridge; total length: about 50m; construction year: unknown)

The girder had shifted horizontally in the direction of the bridge axis. Diagonal cracking had developed in the section of the abutment that carries the girder. A large vertical crack was observed in the middle of the vertical wall of the abutment.

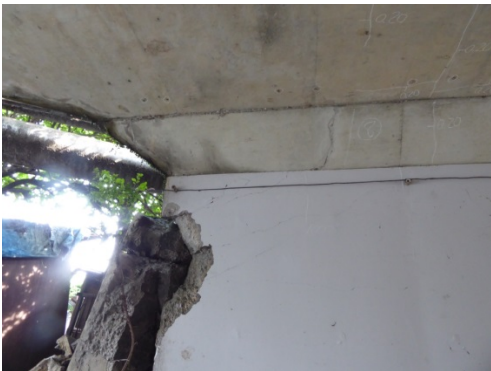
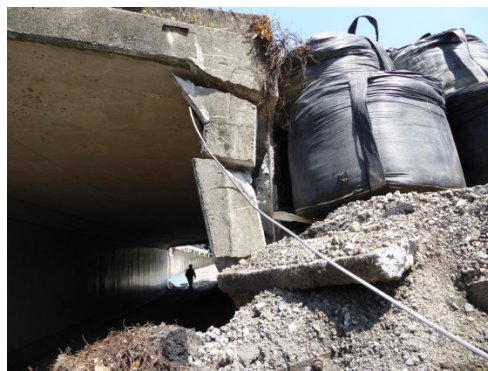
16:00 Box culvert at Terasako Intersection

The retaining wall and the end of the box culvert collided during the earthquake, causing damage that resembles punching shear failure in the end of the box culvert. No other damage that could have been caused by earthquake motion was discovered in the box culvert.

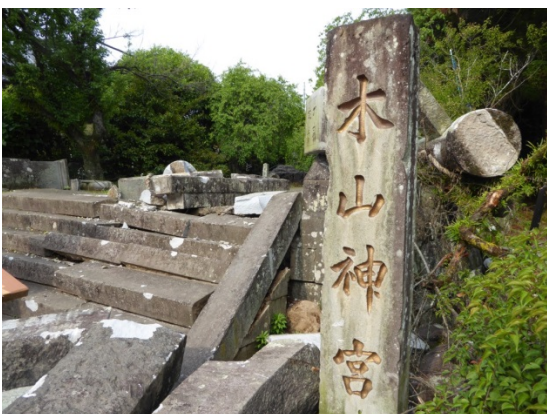
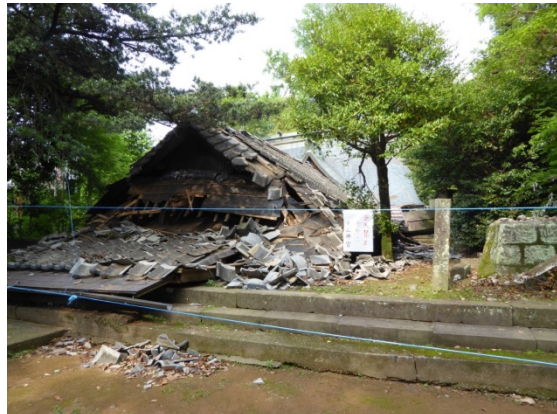
16:30 Kiyama Shrine

As with the Aso Shrine, the shrine building collapsed. Stone monuments, garden lanterns, etc., also fell to the ground.

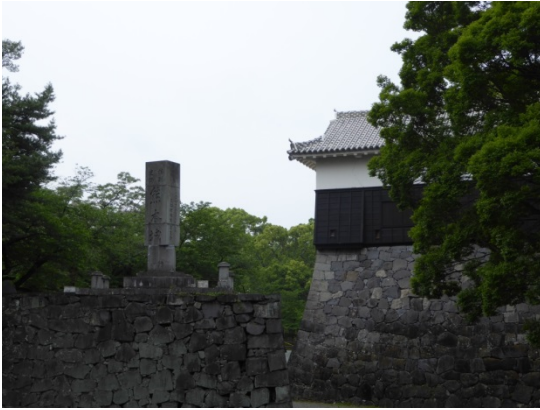
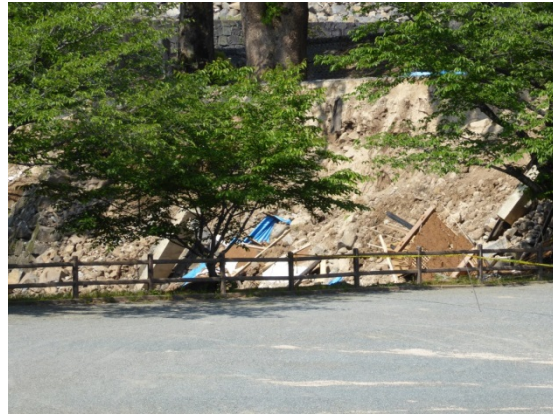
17:00 Kumamoto Castle

The stone castle walls had collapsed in numerous places in connection with embankment failures. Plaster-finished earth walls also collapsed. Some tiles had fallen from the castle tower, etc.

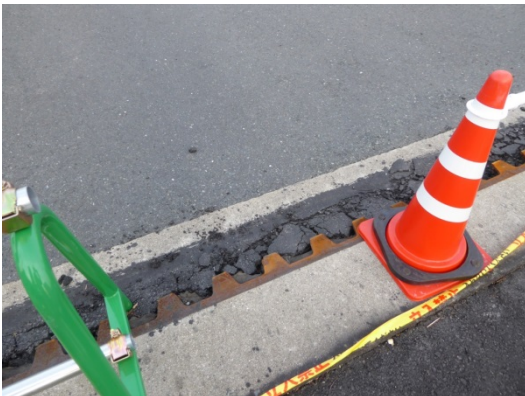
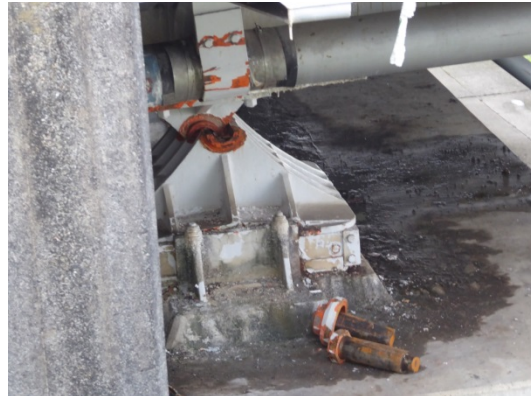
18:00 Shirakawa Bridge (type: Lohse bridge; total length: 69.6m; constructed in 1959)

Girder displacement, road subsidence, etc., were observed. The principal cause is collapse of the pin bearings (on the Kumamoto Station side). The bridge is located on Prefectural Route No. 22 that leads away from the east exit of the station. Thus, closure of the road has had a significant impact on local traffic.
