# Amarube Bridge

## ○ Overview of construction

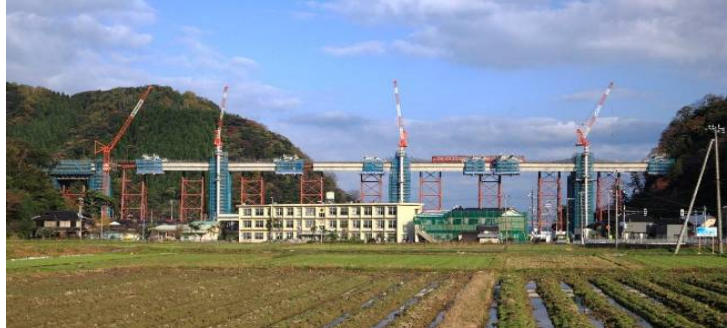
Photo 1 cantilever method of girders erection

The basic technique used to erect the girders was the cantilever method. (See Photo 1.) On the Kyoto side, however, the track immediately crosses the bridge after exiting a tunnel, so the following method of construction was adopted at this end (Figure 3 and Photo 2): (i) the superstructure of the end girder was erected by the cantilever method to the south of the old bridge; (ii) after train services were suspended and the old bridge girder, which interfered with the placement of this end girder of the new bridge, was removed, the new bridge girder was moved in a parallel direction by about 4 m; (iii) after completion of the parallel movement, the girder was rotated by 5.2 degrees to align it with the tunnel and the other girders; (iv) following concrete placement in the closing section, the track was laid.
