Development of Concrete Repair Method Using Thin, Highly Ductile Cement Board (Smooth Board Method)

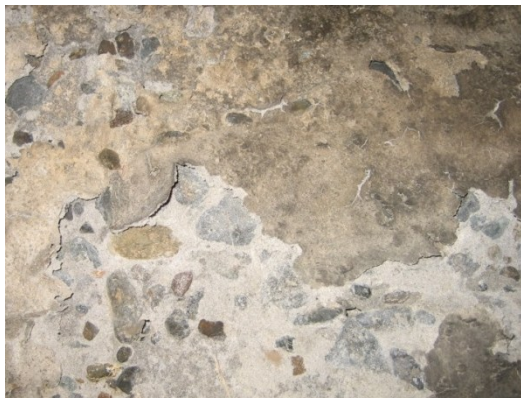
Photo 1. Deterioration of tunnel lining concrete

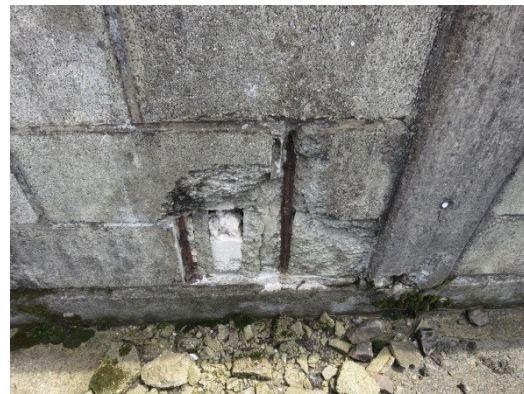
Photo 2. Deterioration of railway side wall (reinforcing steel is corroded and exposed)

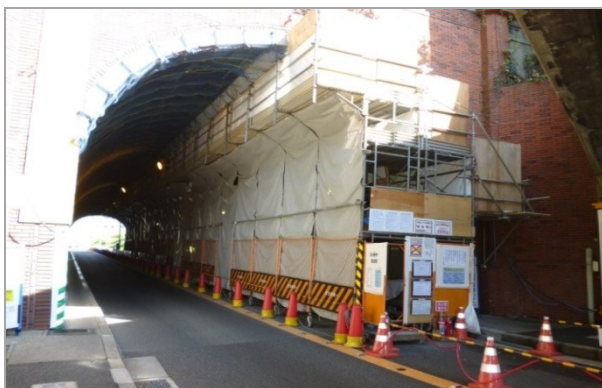
Photo 5. Tunnel lining (one-way alternate traffic)

If the work is carried out in stages using a mortar fill height of up to 2 m per operation, then safety measures can be made very compact, no conventional dedicated protection devices are necessary to block off a vehicular traffic lane, installation of protection sheets using for common frame scaffolding is only necessary (Photo 5). Therefore, one-lane alternate traffic is possible and work can be conducted without blocking the road during the daytime.

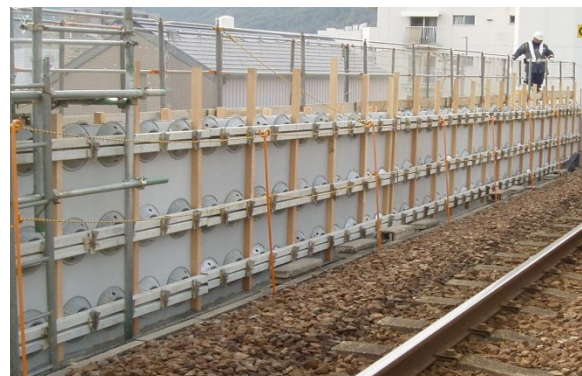
Photo 6. Railway side wall (working near railway traffic)

Since the board can be fixed to an existing side wall using all-screw bolts during erection, it is safe from the wind pressure created by passing trains, thus enabling operations near active railways (Photo 6).

The work space on the track side needs to be only about 60 cm from the existing side wall, which does not block railway traffic. The nuts fastened from the outside should be locking nuts so that they will not be loosened by vibrations from passing trains.

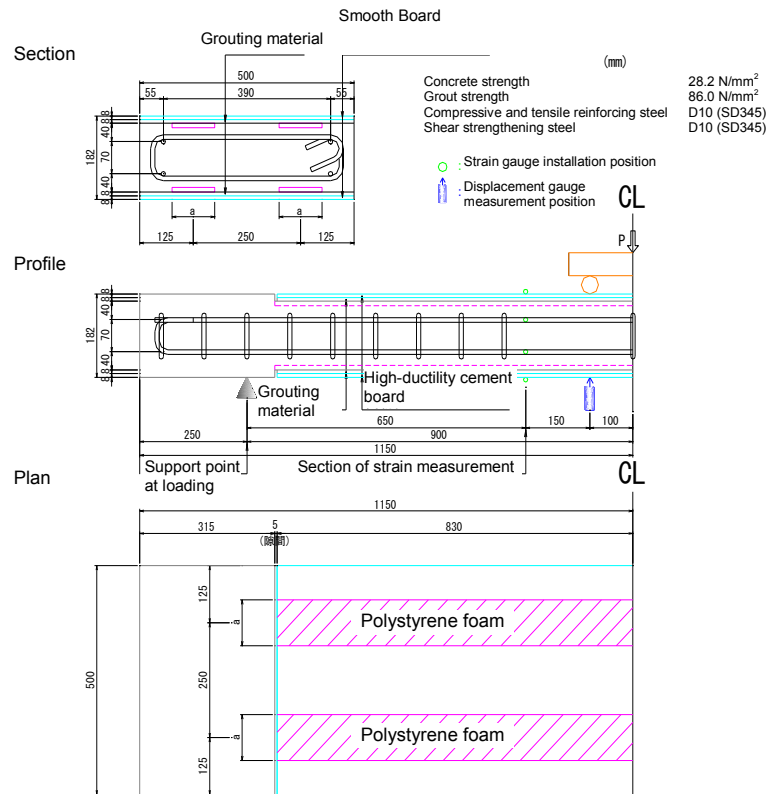
Figure 4. Overview of experiment
(Polystyrene foam: no bonding)

Figure 4 shows an overview of the experiments. Table 2 lists the experiments. In Figure 4, the areas where polystyrene foam was placed are unbonded areas. Assuming a lack of bonding caused by corrosion of the primary steel bars, 250 mm, the most common interval for reinforcing steel, was set as the interval for the polystyrene foam, and the width (a in Figure 4) was set as a parameter.

*1 50, 100, 150 mm correspond to dimension a in Figure 4.

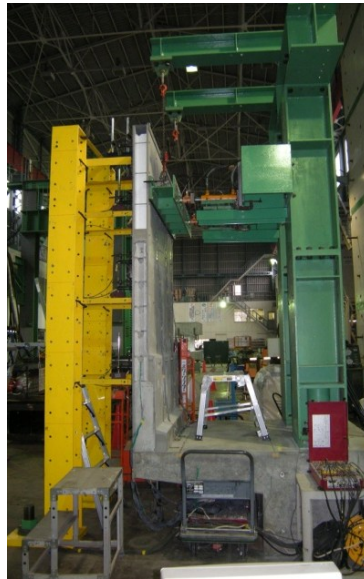
Photo-7 Loading (opposite the positioning in Figure 6)

Figure 7 shows the load-displacement relationship at P2. Photo 7 shows the loading at P1.

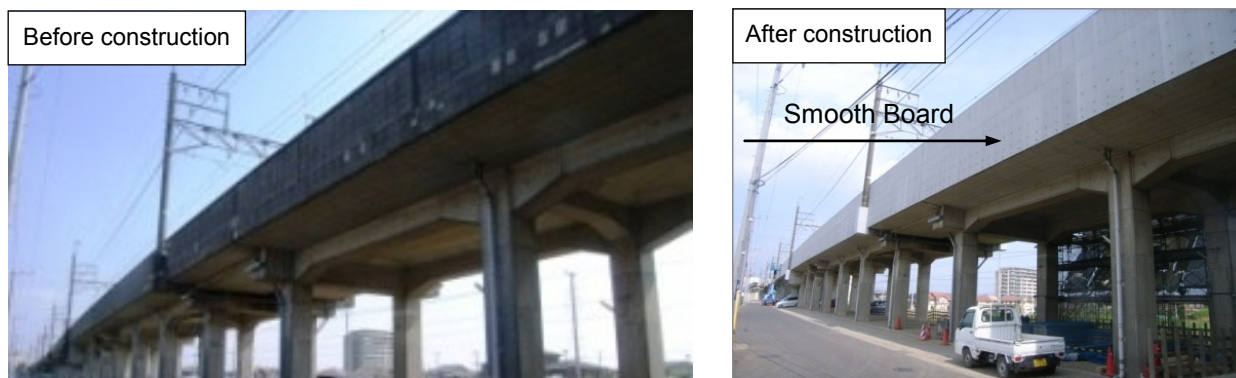
Photo 8. Repair of railway viaduct side wall (1.6 m high before construction; 2.5 m after rehabilitation)

This method was used for repairing and reinforcing a railway viaduct side water that needed to increase its height as a noise control measure for a new high-speed train services and to rehabilitate age-related deterioration (Photo 8).

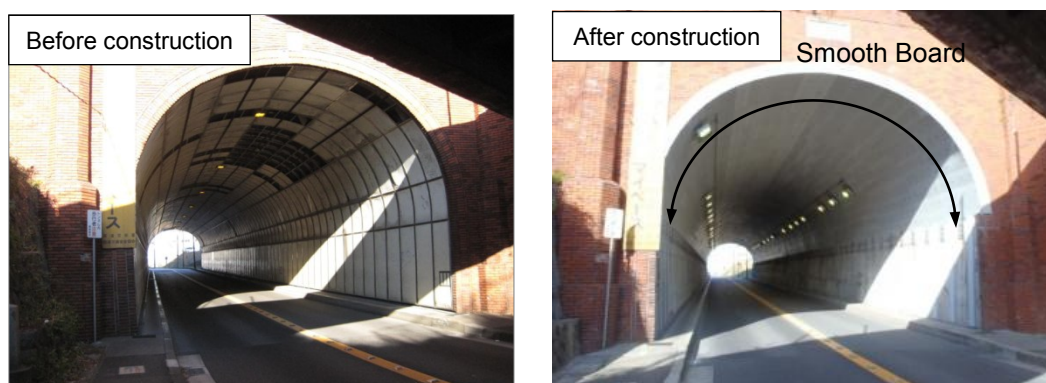
Photo 9. Repair of tunnel lining (additional concrete cast to increase the thickness)

At a tunnel that had been protected from concrete detachment using a simple framework of H steel and interior boards, the lining concrete had deteriorated further. This method was used to place additional concrete in order to increase the thickness of the lining.
