# NON-DESTRUCTIVE INSPECTION OF TENDON GROUTING IN PRESTRESSED CONCRETE BEAMS

## Elastic Wave Velocity Method

Toshiro Kamada, Osaka University

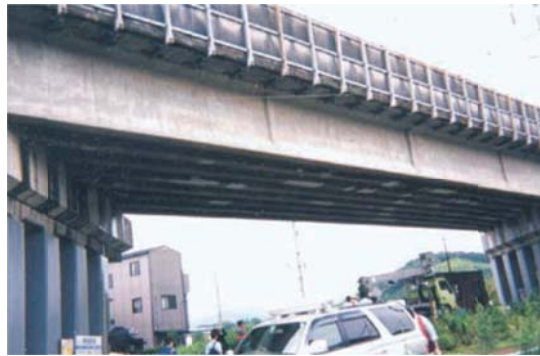
The results of evaluating PC grout condition of the transverse prestressing steel bars in the girders of an in-service PC bridge (shown in Fig. 4) are outlined in this section. This bridge has separate girders for outbound and inbound lanes, each consisting of four main beams, filler members and extension members. These members are integrated into one unit with transverse prestressing steel bars.

Fig. 4 Inspected PC girders

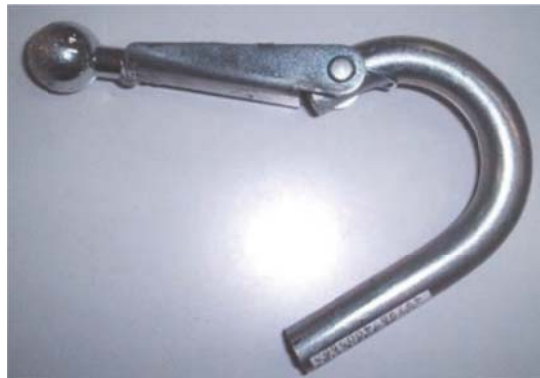
The device shown in Fig. 5 was used to generate the elastic waves. The impact was applied to the ends of the steel bars where they protrude from the extension member. To record the time of elastic wave input, a sensor was installed near the point of impact. The propagated elastic waves were detected with sensors fitted to the concrete side face between the inbound and outbound lanes. The velocity of elastic wave propagation was obtained by dividing the distance between the sensors by the difference in time of wave arrival between the sensors.

Fig. 5 Impact device
