## Example of RC slab deterioration caused by combined ASR and frost attack and verification of its mechanism

Koichi KOBAYASHI, Gifu University, Gifu Japan  
Yutaka KANO, Komaki City, Aichi, Japan  
Keitetsu ROKUGO, Gifu University, Gifu, Japan

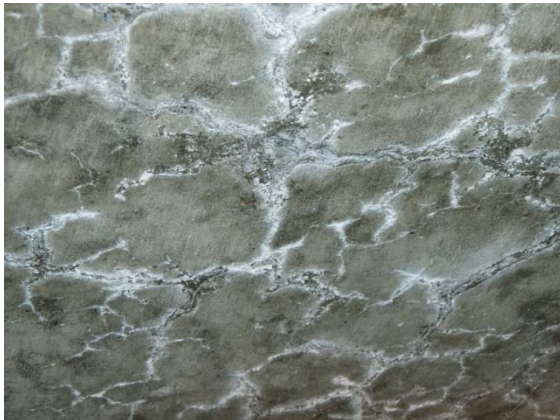
**Photo 1** Mesh-pattern cracks and white deposits on under surface of bridge deck

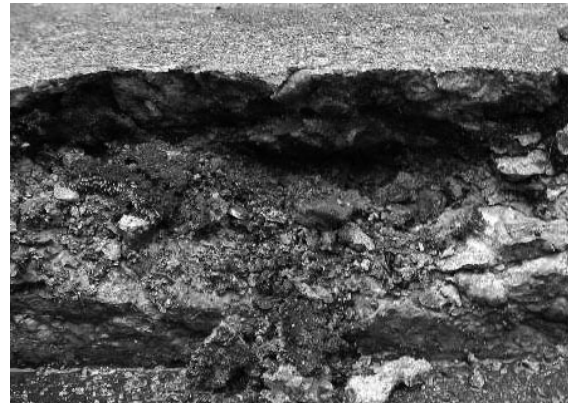
**Photo 2** Severe scaling of wheel guard concrete

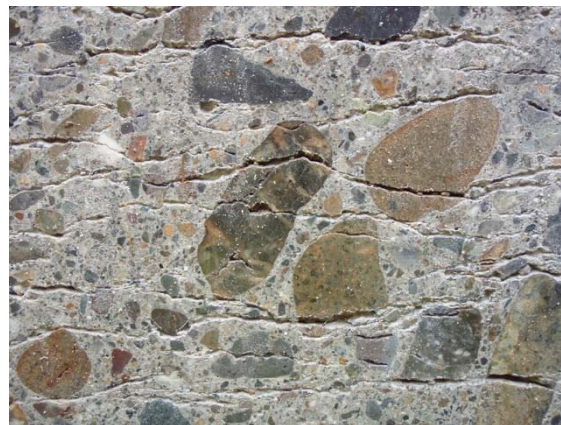
**Photo 3** Horizontal cracks in the cross section of the bridge deck
