# Freedom Bridge Project

# 1 Project Background

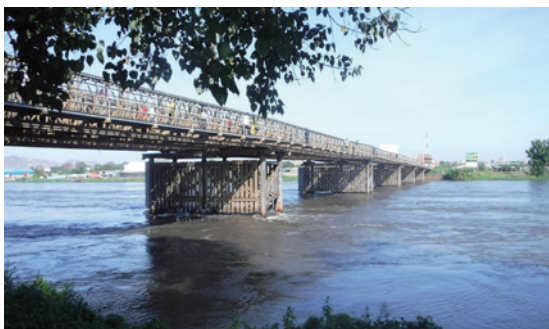
Photo 2: Juba Bridge

The existing Juba Bridge, however, was inherently fragile and had structural deficiencies. Given that bridge’s narrow width and limited capacity for heavy vehicles, the government prioritized the construction of a new bridge. The construction was originally planned for approximately three and a half years (from August 2013 to December 2016). Due to two episodes of civil conflict arising from political confrontation and the COVID-19 pandemic, the project ultimately took about nine years to complete.

road is ongoing, with it regarded as a core route for international logistics. Access into the center of Juba City, however, requires going over Juba Bridge (a temporary Bailey bridge), which spans across the Nile River. This bridge has poor durability, and in the past has suffered structural damage. It is also narrow, meaning large vehicles struggle to get across the bridge, causing traffic jams. Because of these circumstances, the South Sudan government aimed to improve the quality of life of its citizens and reduce poverty by building infrastructure, with economic development and conflict-prevention/safety the main pillars of its South Sudan Development Plan (2011–2013). Particular examples of government policy goals include the development of a paved trunk-road network and the reduction in the risks of future crises and conflicts. To encourage development of the city and facilitate logistics, the construction of a new bridge over the Nile River was a key challenge for the South Sudan government. By constructing a new bridge a few hundred meters upstream from the existing Juba Bridge, as well as a road that connects to it,

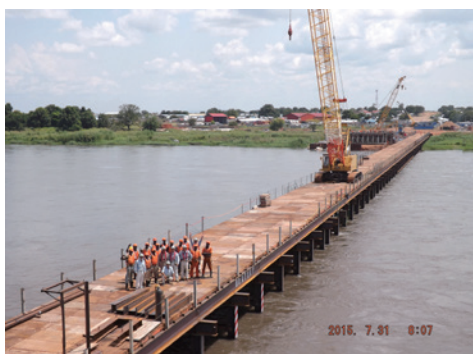
Photo 4: Temporary Bridge Completion

After resuming the construction work in February 2015, in the second half of February, work began on building the 450-meter temporary bridge across the Nile River and the substructure on the land side. In October, construction began on the river substructure using the temporary bridge. In April 2016, work also began on the superstructure of the land section, with 150 meters of steel girders erected by June.

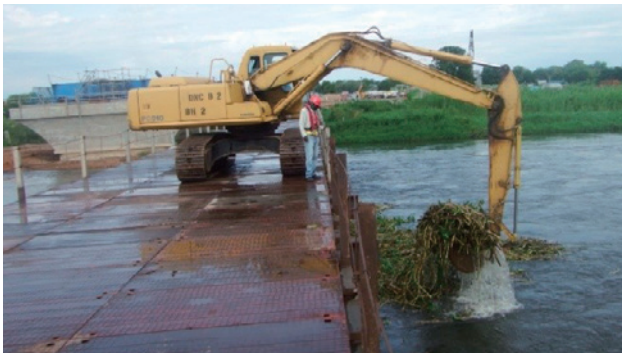
Photo 6: Site Maintenance by Local Staff

Although operations at the worksite were completely suspended for approximately three years from the second evacuation up to the resuming of the project, local staff had continued to manage the site, keeping it in a good state.

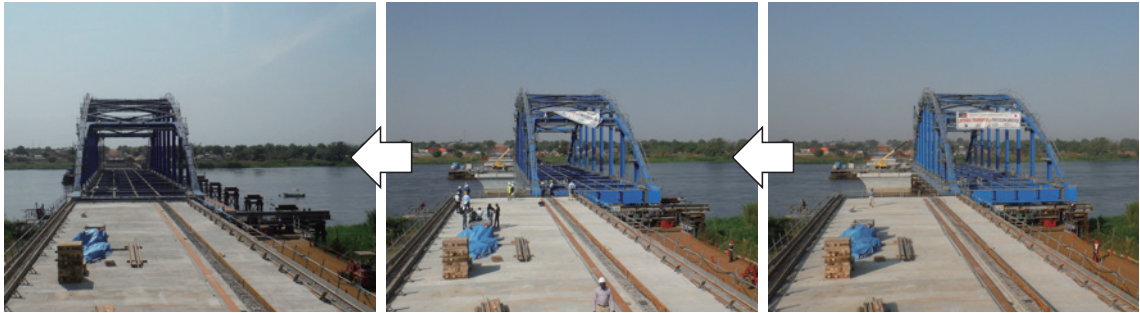
Photo 8: Lateral Sliding of Langer Bridge

After resuming the project for a second time, the main construction work shifted from the substructure to the superstructure, and the substructure was completed in December 2019. In November, work began on installing the Langer bridges over the river. In January 2020, the first of four Langer bridges was completed using the lateral sliding method.

Of the bridge's total length of 560 meters, the 350-meter river section consists of four Langer bridges, while the land sections are made up of plate girders. The four Langer bridges were put in place by installing an 80-ton crawler crane on the 6-meter-wide temporary bridge set up on the downstream side and using the bent assembled on both sides of the temporary bridge.

Once the installation was finished, the high-strength bolts were fully tightened, and the jack on the bent was released. After that, the girders were laterally moved 14.5 meters

to their specified location on the bridge. For the lateral-shift setup, an extra-thick H-beam was placed, a 500 kN tension jack provided the driving force, and 12 mm Teflon sheets were used as the sliding pads. Repeating strokes of 500 mm, the work to laterally shift a single Langer bridge took roughly six hours.

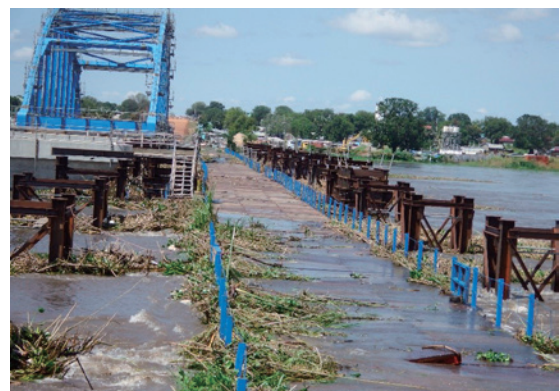
Photo 9: Water Level Overflowed Temporary Bridge

At the project site, in October, the water level of the Nile River rose, causing the temporary bridge to overflow several times. Although driftwood and other debris coming from upstream pushed against the temporary bridge, causing it to lean about 10 cm toward the downstream side, the local staff prevented it from worsening by performing routine maintenance work.

During the COVID-19 evacuation period, as mentioned earlier, the rise in the Nile River's water level caused the temporary bridge to tilt downstream, and therefore, work was done to reinforce the slanted section. Inspections were also carried out at each location, and work resumed for the third time, with sights set on completion.

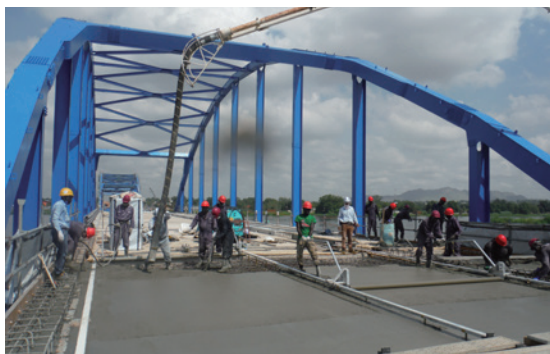
Photo 10: Bridge Slab Concrete Casting

In January 2022, all slabs had been laid, and at the same time, work had begun to remove the temporary bridge. A part of the temporary bridge, a section of which, had been swept away, was greatly slanted, and so work to remove the bridge was extremely challenging. It was removed in early April.
