Report by the First Joint Survey Team of the JSCE Concrete and Structural Engineering Committees on the damage caused by the Great East Japan Earthquake

April 5, 2011 (First Report)

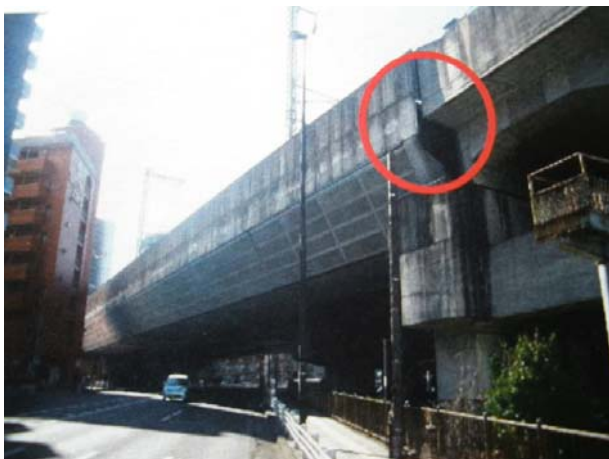
Fig. 1 General view of the bridge
(Source: East Japan Railway Company)

This bridge is a composite box girder bridge with a length of 74,500 mm. The earthquake motion caused breakage of the pin at the fixed parts of the bearings and there was a sideways movement of about half the width of the bearings. Repair work involving jacking up the girder had been completed by the time of this survey. The work was carried out without the need to close the national road running under the bridge, since there were concrete walls on both sides of bridge abutment and there was no possibility of the girders falling down.
