Renovation of the Genta Bridge: Increasing the Lane Width and Load Resistance

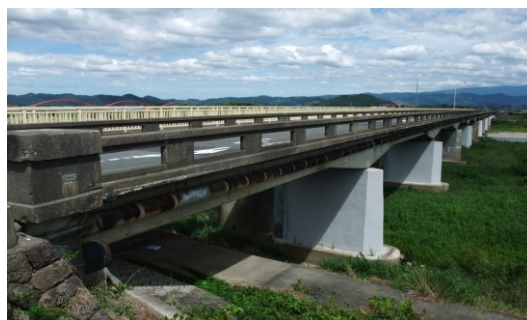
Photo 1. Genta Bridge before renovation

After over 60 years of operation, the bridge was aging and declining in function and load resistance. However, a preliminary investigation revealed that the concrete strengths of the bridge legs and main girders were high— $25\text{--}48\text{N/mm}^2$ and $36\text{--}54\text{N/mm}^2$, respectively—and corrosion and cracking were minor (Photo 2). Moreover, neutralization had progressed slowly and the chloride ion concentrations were low. Hence, the bridge could be renovated rather than replaced.

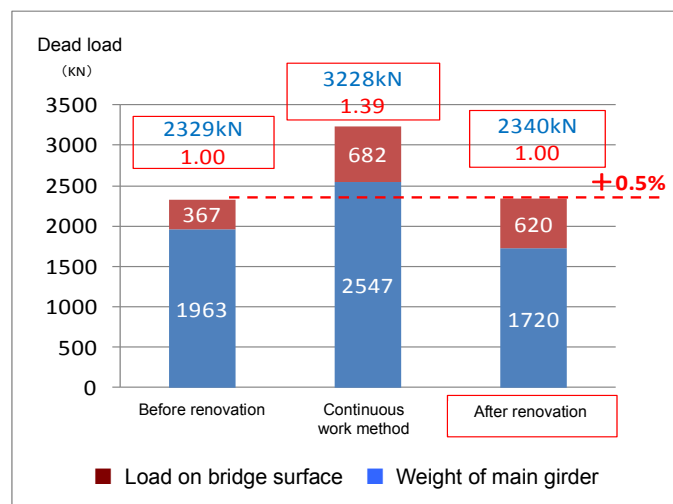
Figure 6. Difference in dead load

The dead load was reduced by applying several measures to the bridge surface, including the use of lightweight aluminum railings. Figure 6 shows the difference in the dead load before and after the renovation. The dead load per bridge leg was 2329 kN before the renovation. After the renovation, it was 2340kN, showing that the dead load increased only by about 0.5%. This method reduced the dead load by about 40% more than the continuous work method used in similar renovation works.

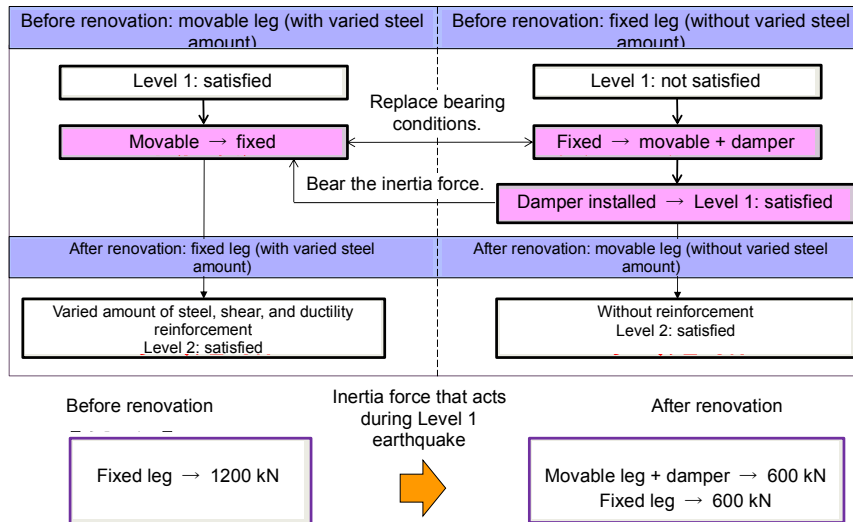
Figure 7. Study flow of seismic resistance

Figure 7 is a flow chart of the study of the bridge's seismic resistance. The bridge legs had nearly the same shape and volume of steel reinforcement, but the movable legs contained sections in which the reinforcement volume had been changed while the fixed legs did not. While the dead load after extending the width was limited to the level before renovation, the study showed that the movable legs satisfied the Level 1 seismic ground motion specification but the fixed legs did not. Neither the movable legs nor the fixed legs satisfied the Level 2 seismic ground motion specification.

To increase the seismic resistance, a polymer cement mortar spray method that blocked less of the river's cross-sectional area after reinforcement. The bearing conditions were changed by replacing the movable legs with fixed legs and the fixed legs with movable legs. Moreover, dampers were installed on the replaced movable legs (Photo 7) in order to bear the inertia force. The dampers increased the inertia force for the movable legs (fixed legs after renovation) but decreased that of the fixed legs (movable legs after renovation). Increasing the steel volume, shear, and ductility, satisfied the seismic resistance requirement and limited the load imposed on the foundation.
