ASSESSMENT OF PC BRIDGE BASED ON TESTING REMOVED BEAM AGED FOR 40 YEARS

Keiichi AOKI, Shinya WATANABE, Takashi SANGA, Kenichi MIYANAGA
and Hiroshi MUTSUYOSHI

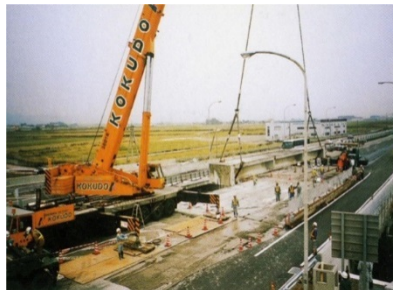
Photo 1 Removal of beam

The PC girder tested in this investigation is a post-tensioned PC T-girder completed in 1971. It originally formed part of a bridge along the Hokuriku expressway located within 100 m of the Japan Sea shoreline. The girder was removed from the bridge in 1997 when the design live load was upgrade to the B

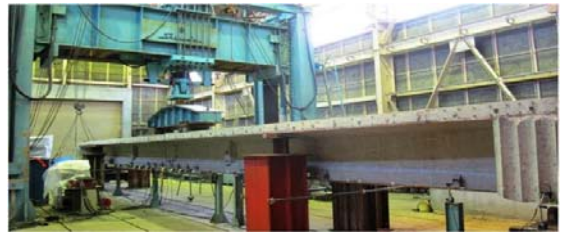
Photo 5 Load test arrangement

The intention of this test was to confirm the flexural capacity of the PC girder. Prior to testing, five PC wires ($\phi 7 \text{ mm} \times 12 \text{ mm}$) were individually cut with the goal of simulating corrosion or failure of the wires resulting from lack of grout. Figure 2 shows the experimental procedure. Photo 5 illustrates the test arrangement and Fig. 2 outlines the test procedure used.
